Sample Log and Notes

46	Kalaeloa Building 46
----	----------------------

LABORATORY REPORT

Client: Riecke Sunnland Kono Architects, Ltd. Building: Kalaeloa Building 46
Address: P.O. Box 1627 Kahului, HI 96732-1627 Enterprise Avenue Kalaeloa, HI
NVLAP LAB CODE 101807-0
Approved Signatory:

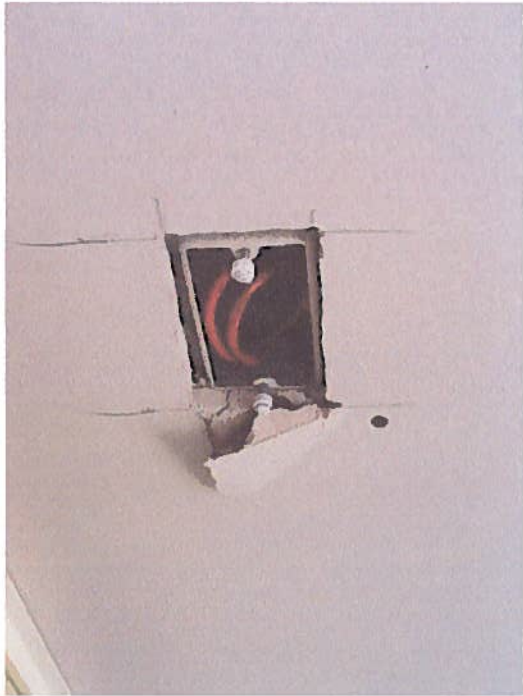
Sample Area # 302-46-1C
Suspect Material: gypsum
wallboard/mudjoint wall &
ceiling system

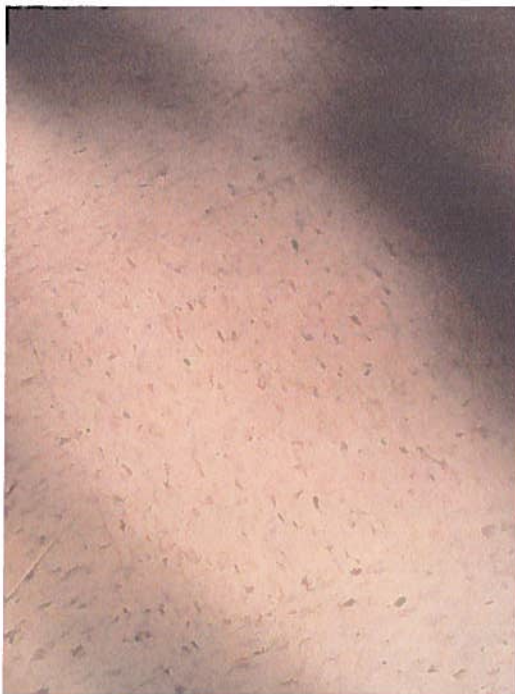
Sample Area # 302-46-1D
12"x12" cream w/gray
specks VFT

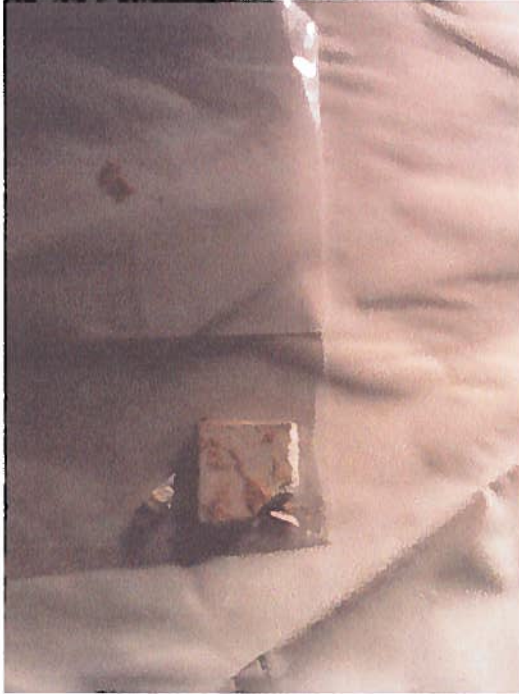
Sample Area # 302-46-1E
beige adhesive (beneath
12"x12" cream w/gray
specks VFT)

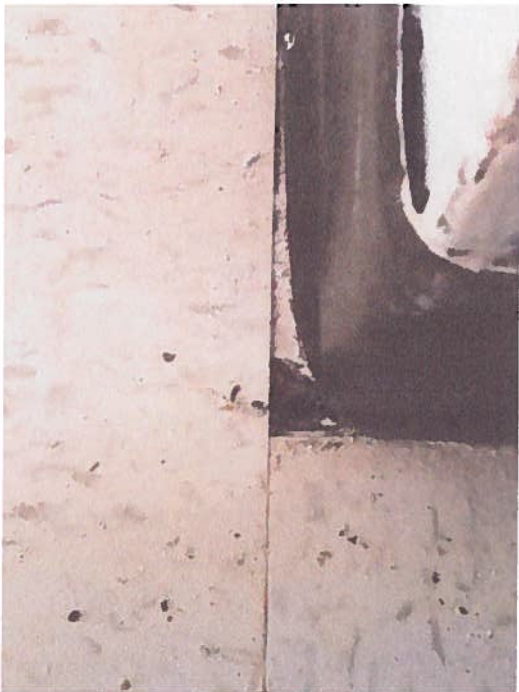
Sample Area # 302-46-1F
black VAT

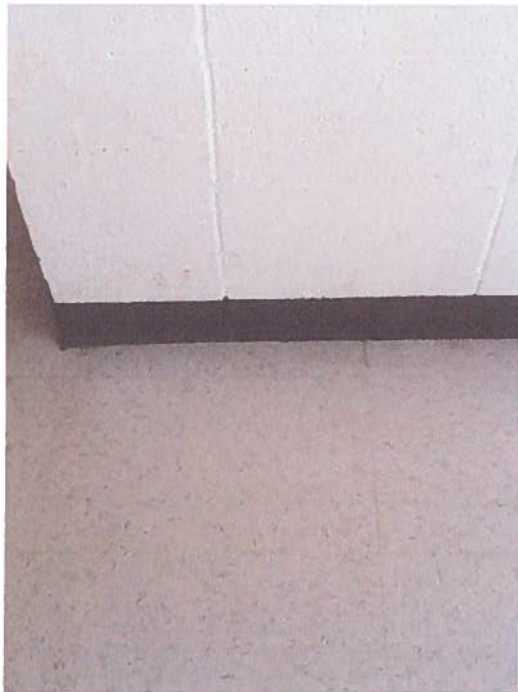
Sample Area # 302-46-1H
4" brown covebase

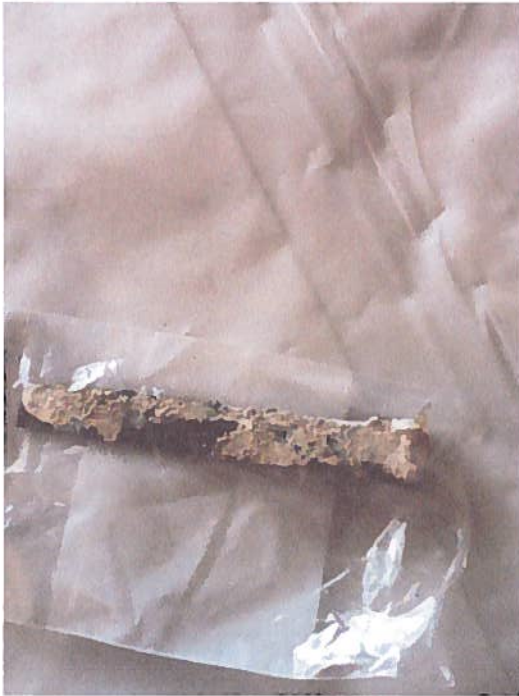
Sample Area # 302-46-1I
beige adhesive (beneath 4"
brown covebase)

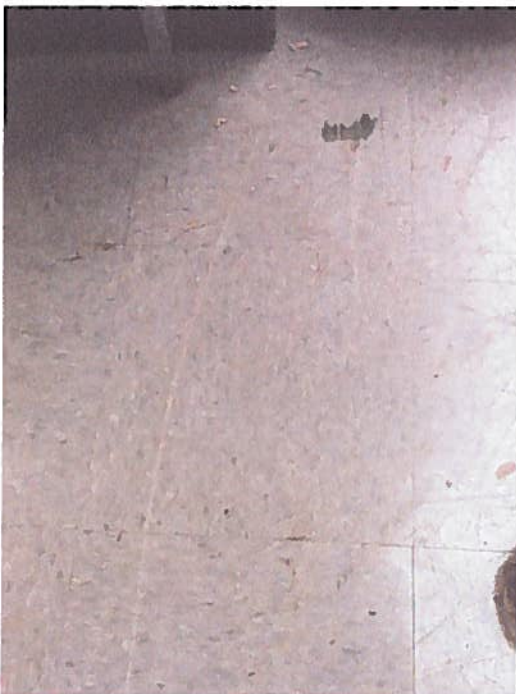
Sample Area # 302-46-1J
12" X 12" light-gray w/
dark-gray streaks VFT

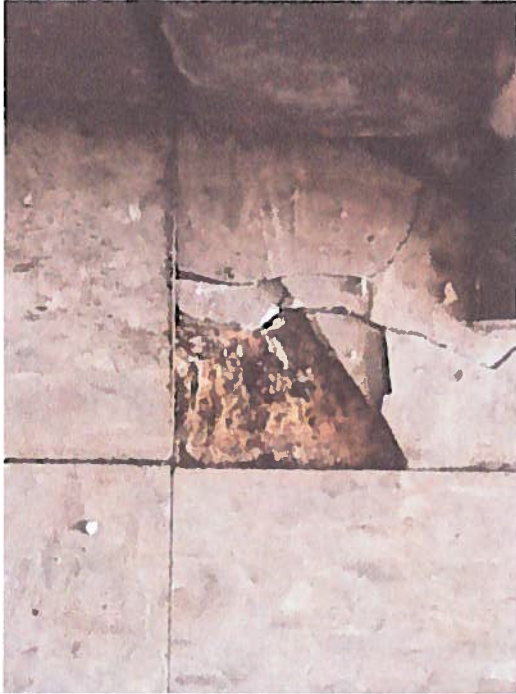
Sample Area # 302-46-1K
beige adhesive (beneath
12"X12" light-gray w/dark-
gray streaks VFT)

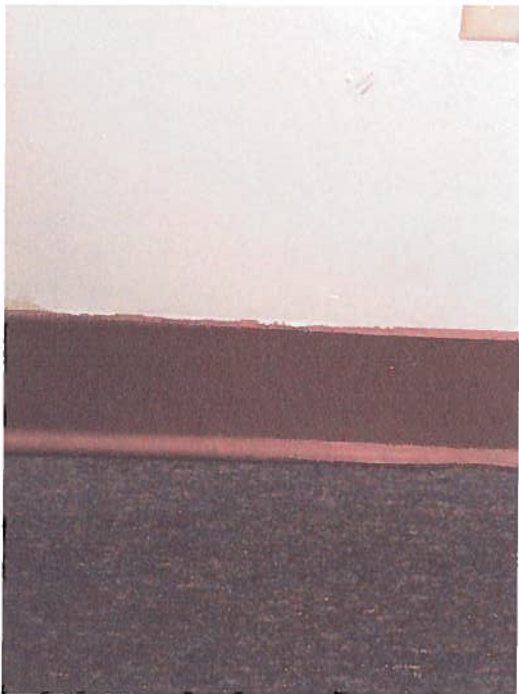
Sample Area # 302-46-1L
4" mauve covebase

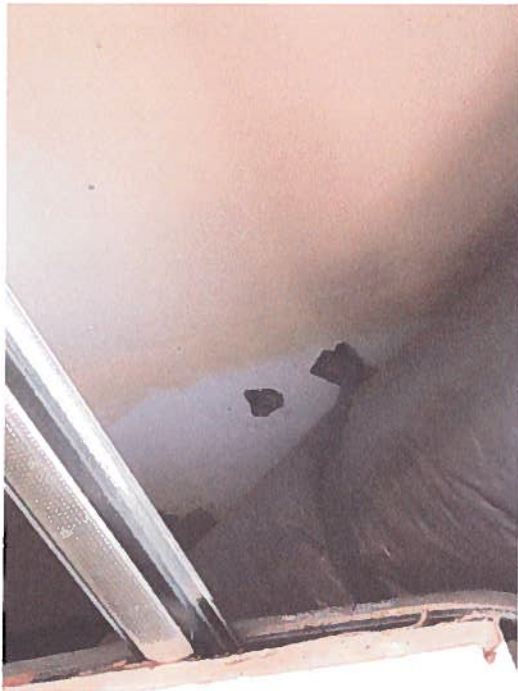
Sample Area # 302-46-1N
gray plaster ceiling

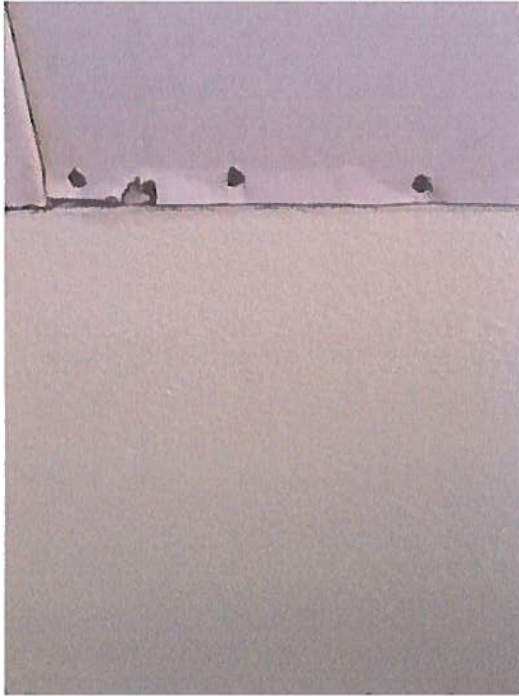
Sample Area # 302-46-10
white skimcoat

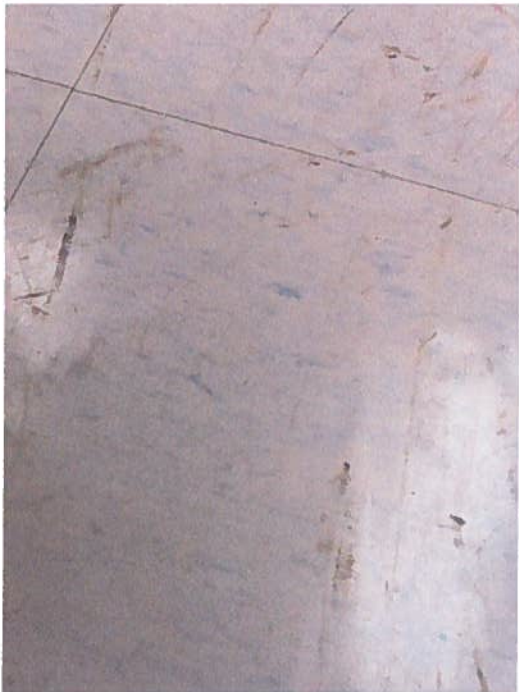
Sample Area # 302-46-1P
12"x12" cream w/blue
specks VFT

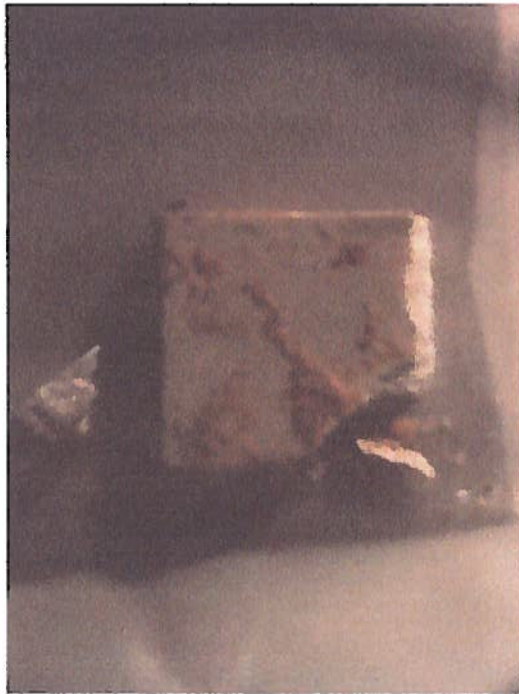
Sample Area # 302-46-1Q
beige adhesive (beneath
12"x12" cream w/blue
specks VFT)

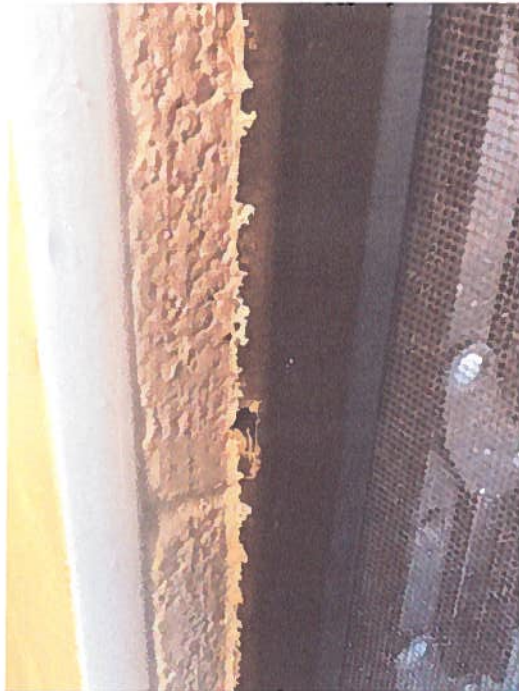
Sample Area # 302-46-1T
gray caulking at window
frame

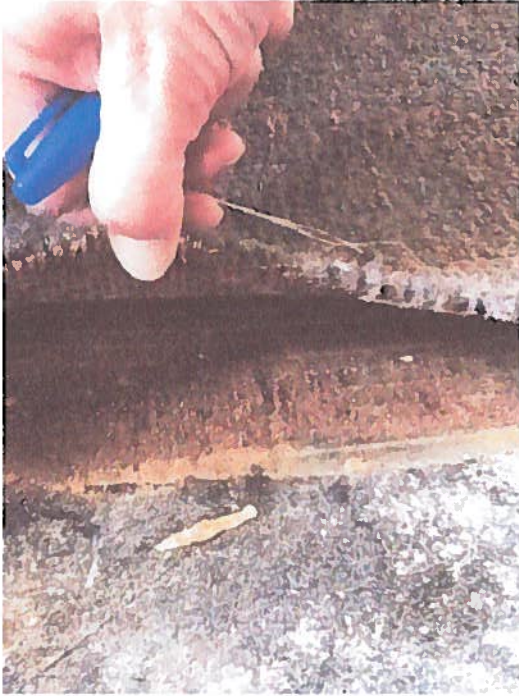
Sample Area # 302-46-1U
yellow/black carpet
adhesive

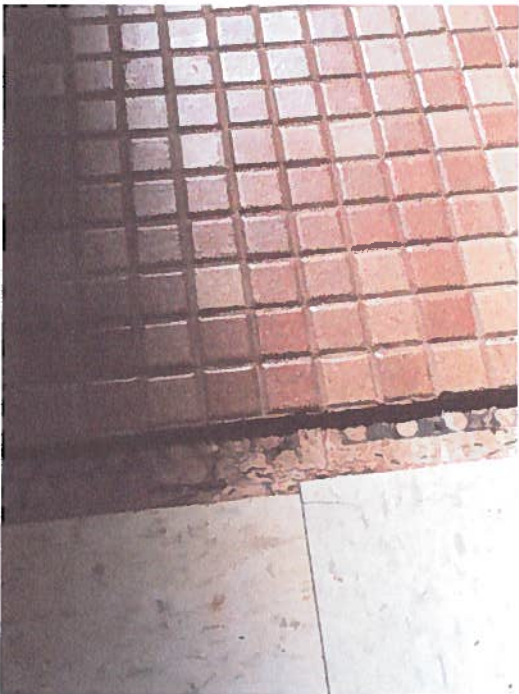
Sample Area # 302-46-1V
beige grout

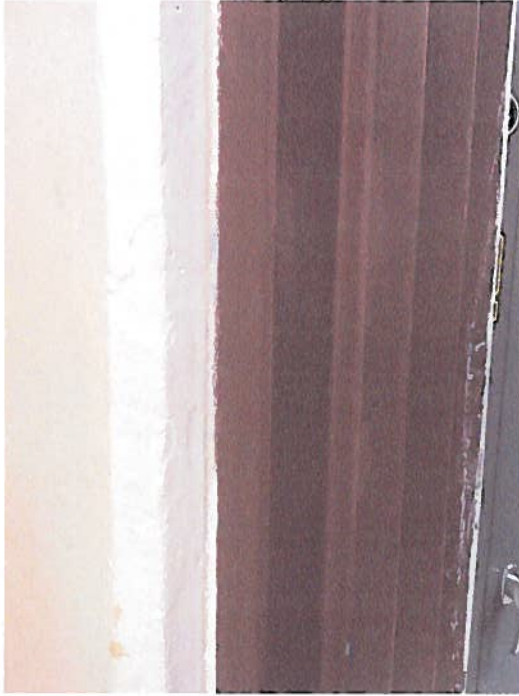
Sample Area # 302-46-1W
white caulking at door frame

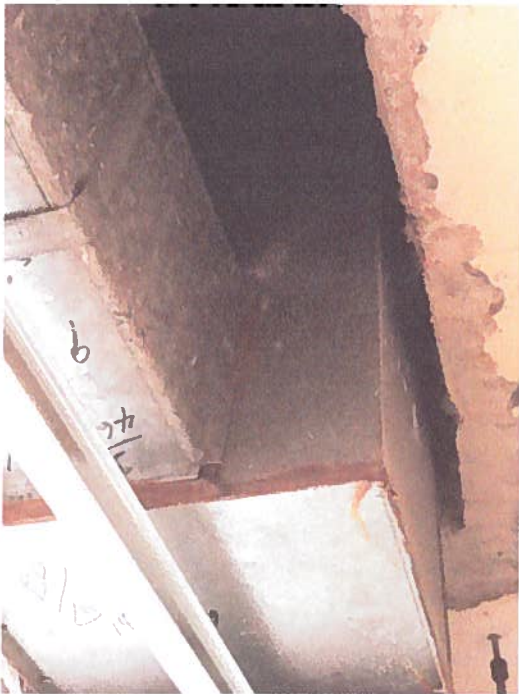
Sample Area # 302-46-1X
tan caulking at duct

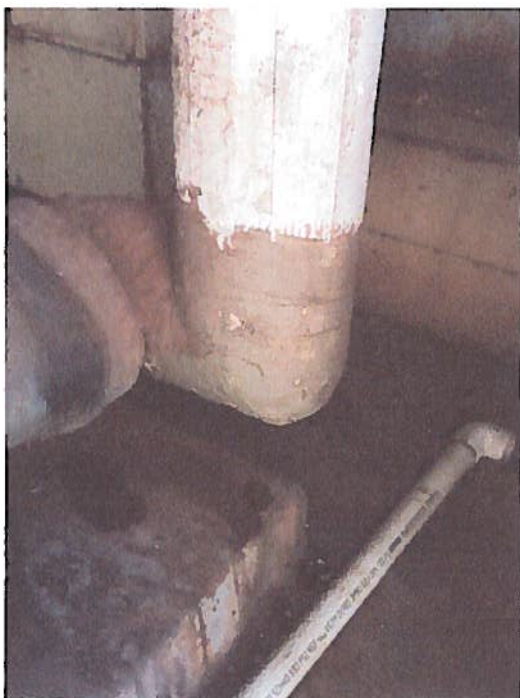
Sample Area # 302-46-1Y
gray sealant on TSI

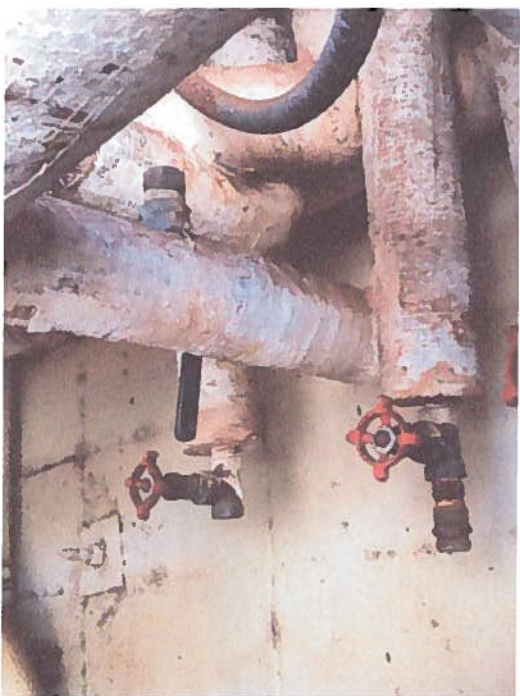
Sample Area # 302-46-Z
white mudjoint on TSI

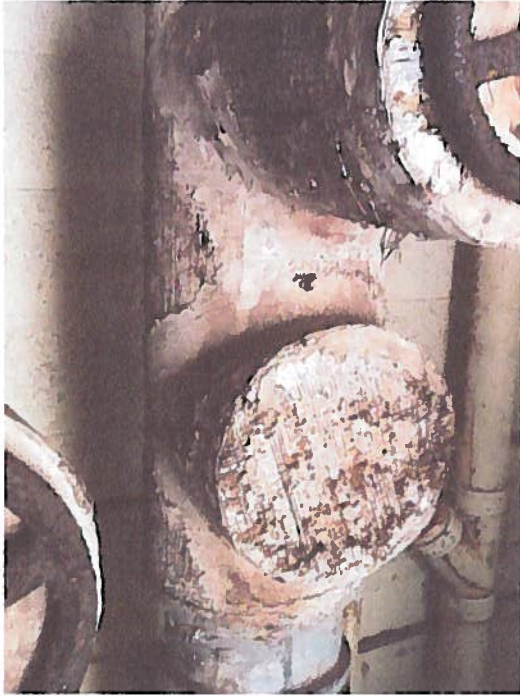
Sample Area # 302-46-1AA
10" o.d. white wrap w/
yellow insulation TSI

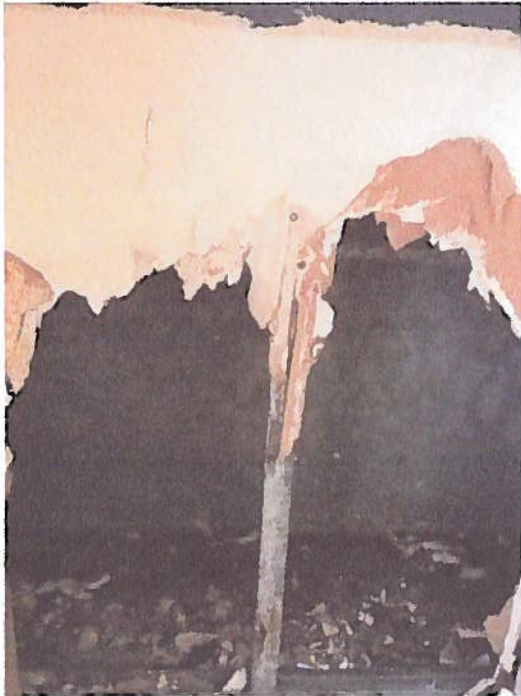
Sample Area # 302-46-2A
gypsum wallboard/mudjoint
wall & ceiling system

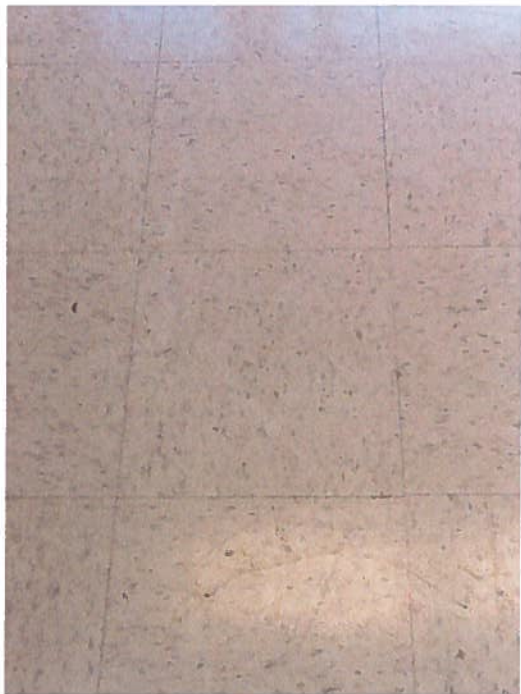
Sample Area # 302-46-2B
12"x12" cream w/gray
specks VFT

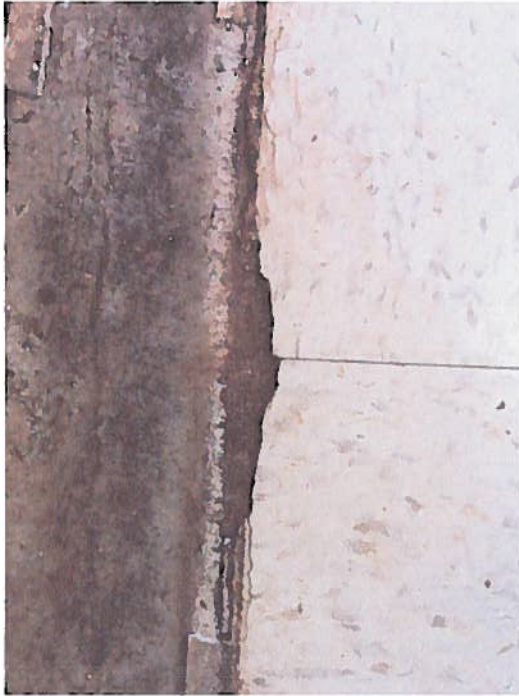
Sample Area # 302-46-2C
beige/black adhesive
(beneath 12" X 12" cream w/
gray specks VFT)

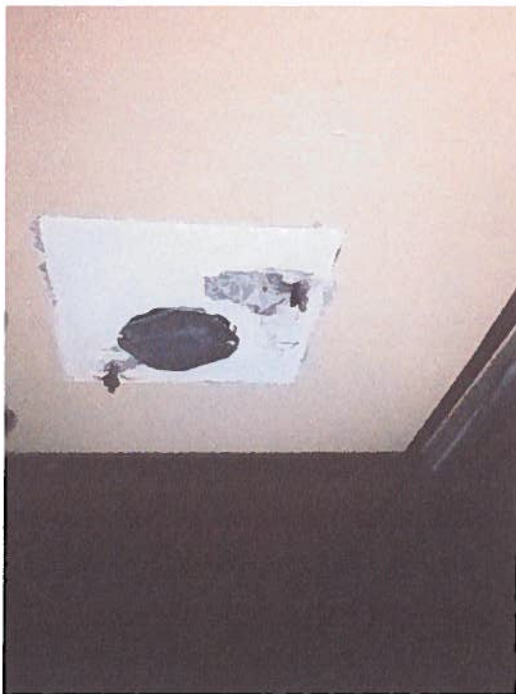
Sample Area # 302-46-D
gray plaster ceiling

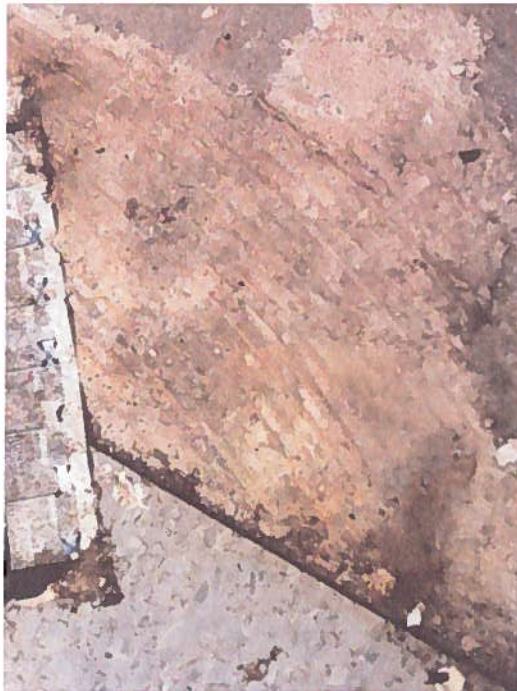
Sample Area # 302-46-2F

beige adhesive beneath
12" X 12" light-gray w/
dark-gray streaks VFT

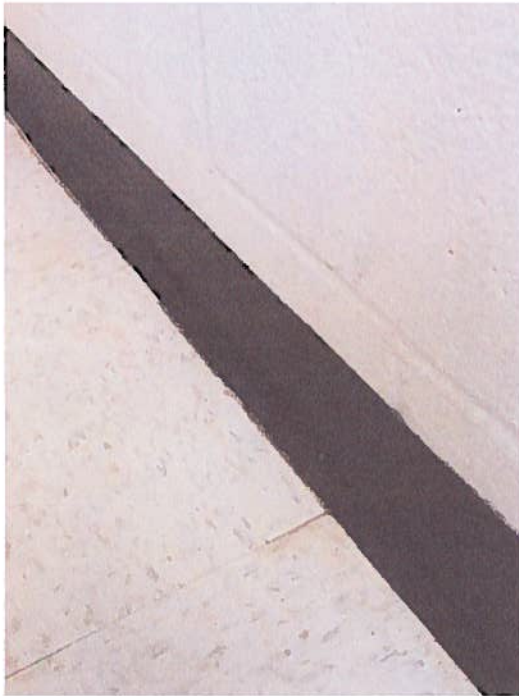
Sample Area # 302-46-2G
Suspect Material: 4" brown
covebase

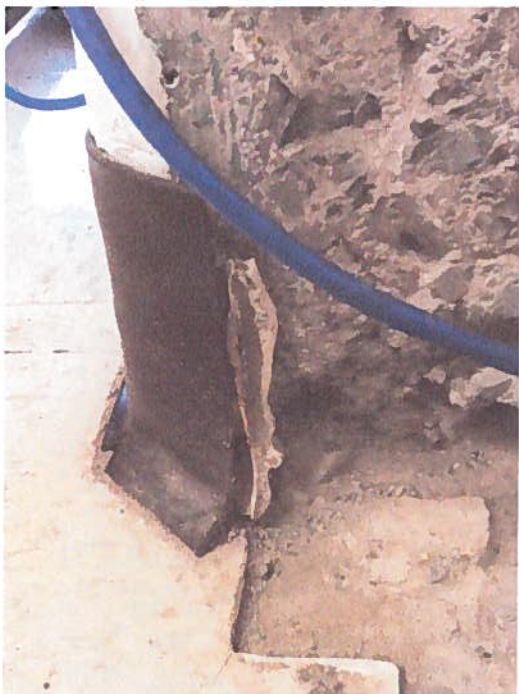
Sample Area # 302-46-2H
Suspect Material: beige
adhesive (beneath 4"
brown covebase)

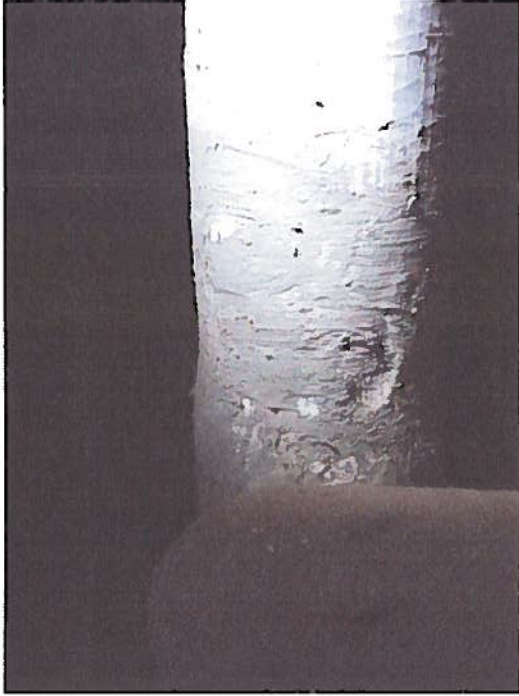
Sample Area # 302-46-2I
gray sealant on TSI

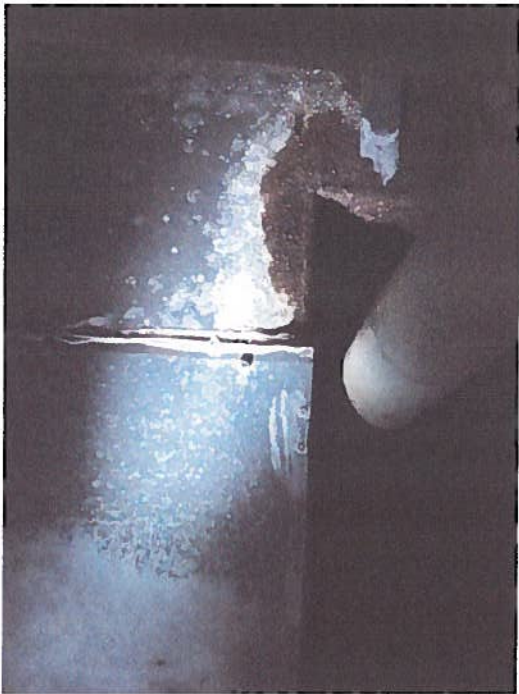
Sample Area # 302-46-2J
white caulking on duct

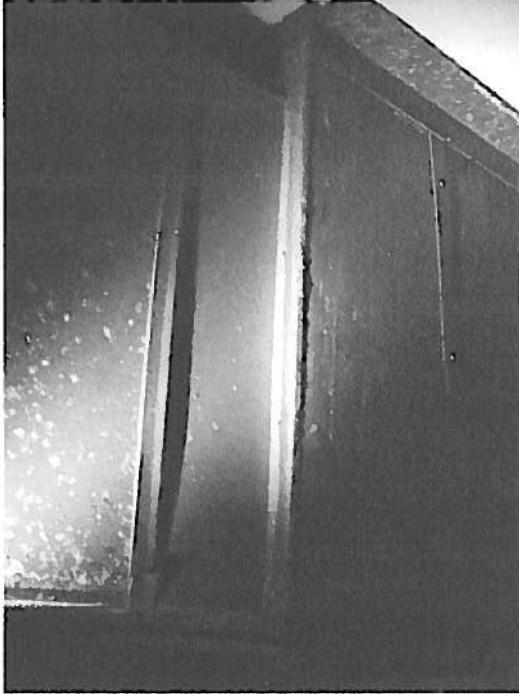
Sample Area # 302-46-2K
tan caulking on duct

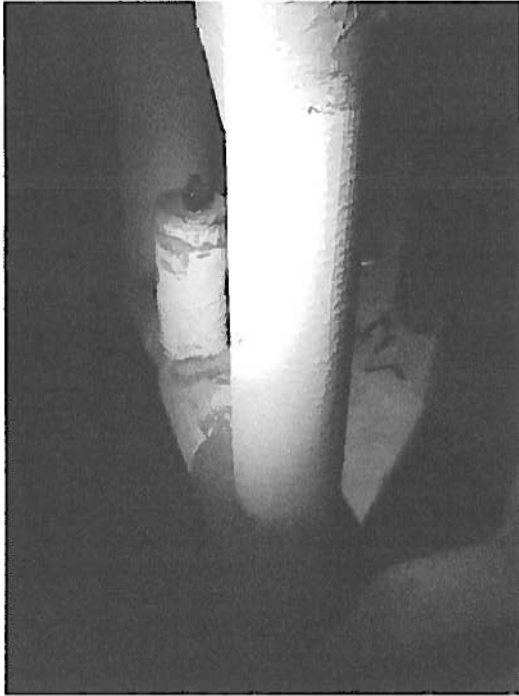
Sample Area # 302-46-2M
6" o.d. white wrap w/
yellow TSI

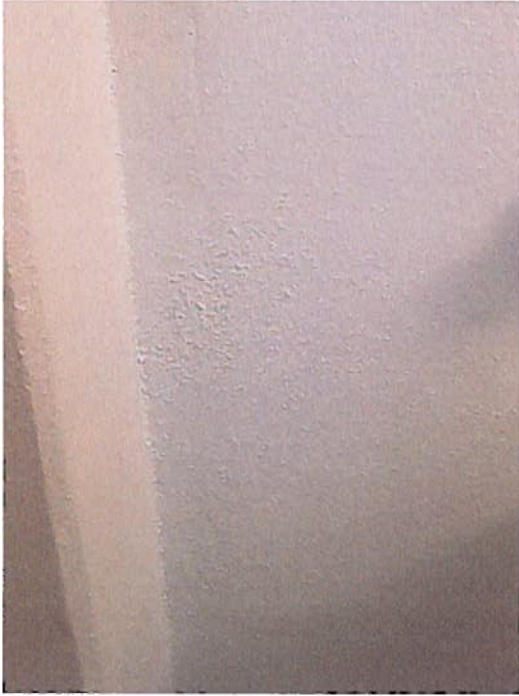
Sample Area # 302-46-20
white skimcoat

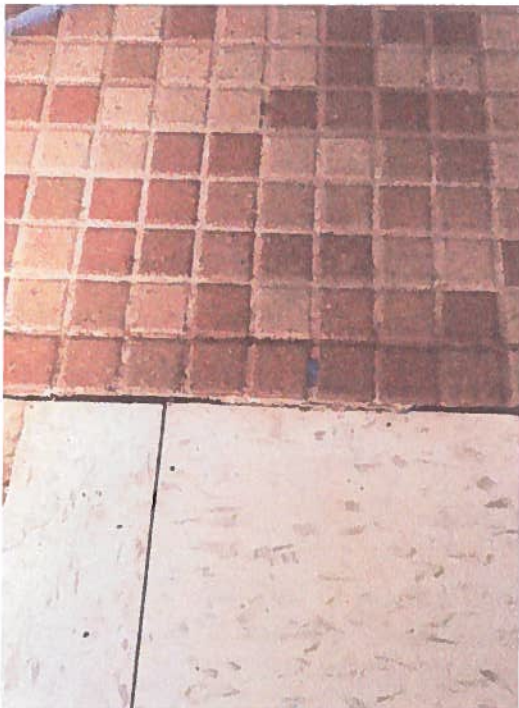
Sample Area # 302-46-2P
beige grout

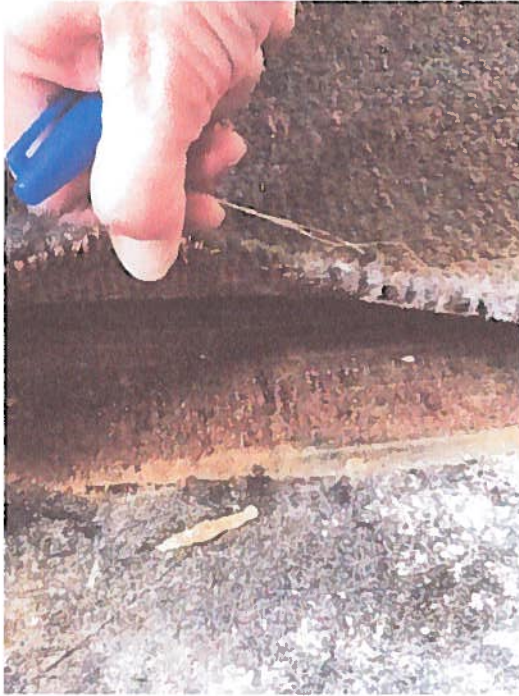
Sample Area # 302-46-2Q
beige carpet adhesive

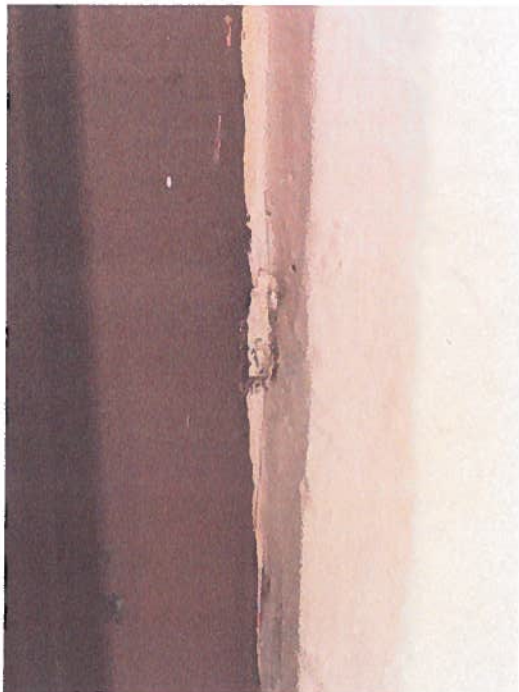
Sample Area # 302-46-2R
white caulking at door
frame

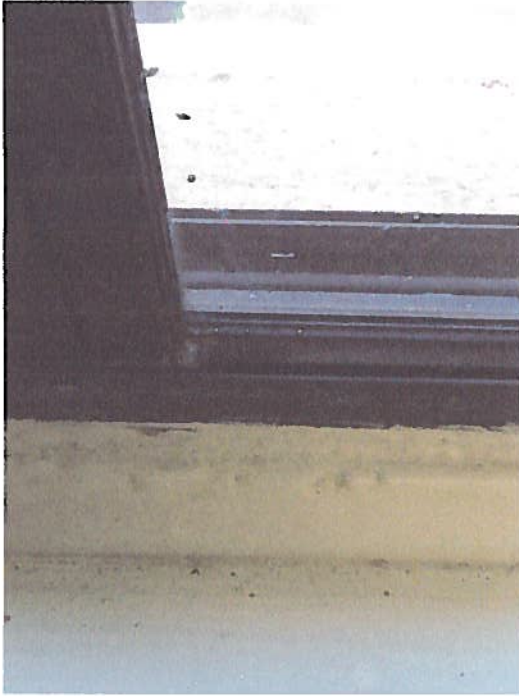
Sample Area # 302-46-2S
gray caulking at window
frame

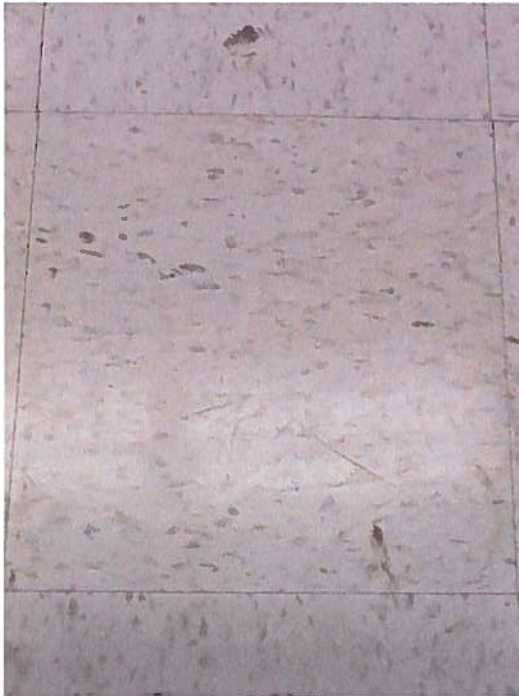
Sample Area # 302-46-3A
12"x12" cream w/gray
specks VFT

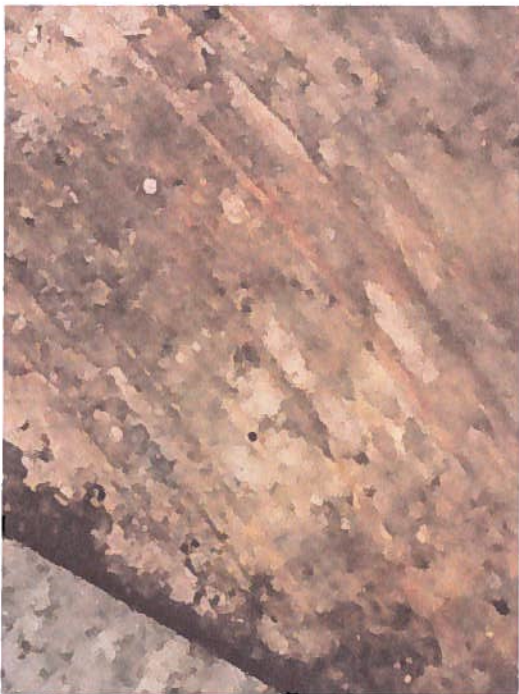
Sample Area # 302-46-3B
beige adhesive (beneath
12"x12" cream w/gray
specks VFT)

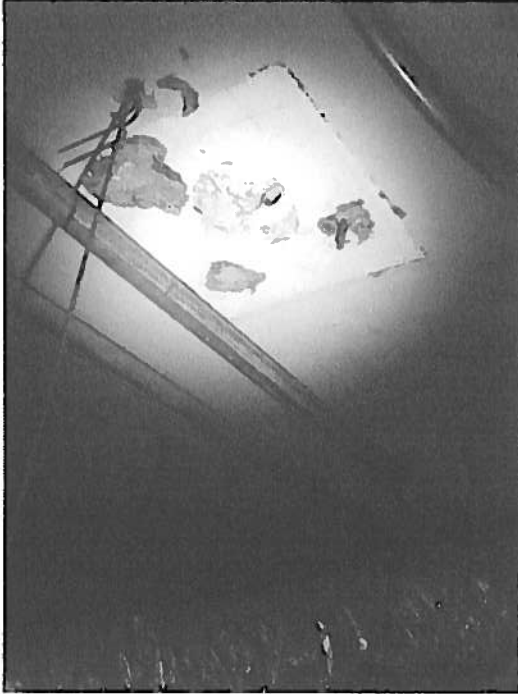
Sample Area # 302-46-3C
gray plaster ceiling

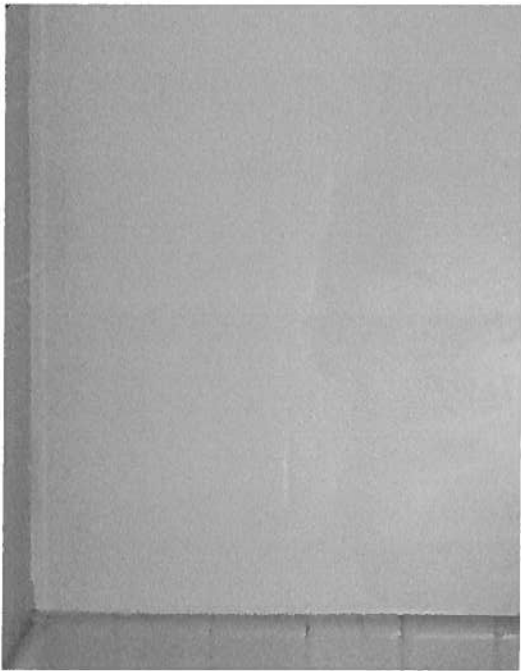
Sample Area # 302-46-3D
gypsum wallboard/
mudjoint wall and ceiling
system

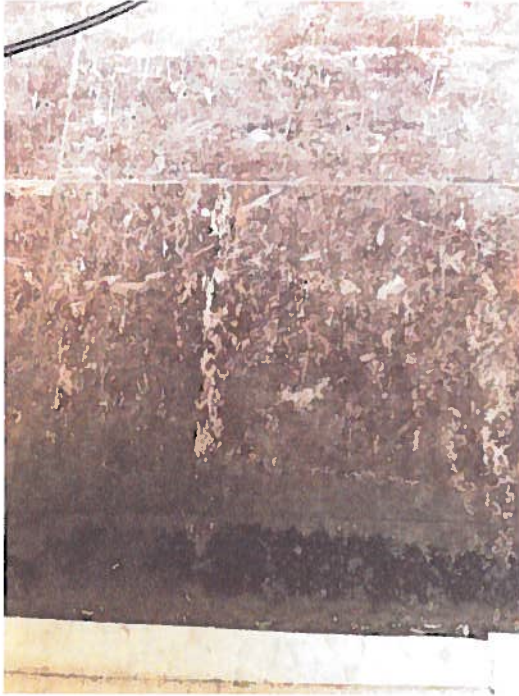
Sample Area # 302-46-3E
9"x9" burgundy w/tan
streaks VFT

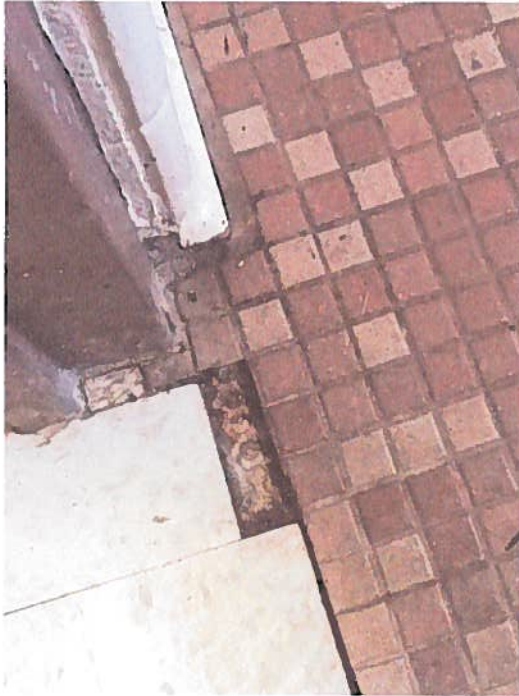
Total number of samples collected	3
Total number of samples analyzed	3
IS ASBESTOS-CONTAINING MATERIAL PRESENT?	NO
Samples Collected by	EMET
Sample Numbers	302-46-3g1, 302-46-3g2, 302-46-3g3
Samples Analyzed by	EMET
Number of Salient Designations

Sample Area # 302-46-3G
beige grout

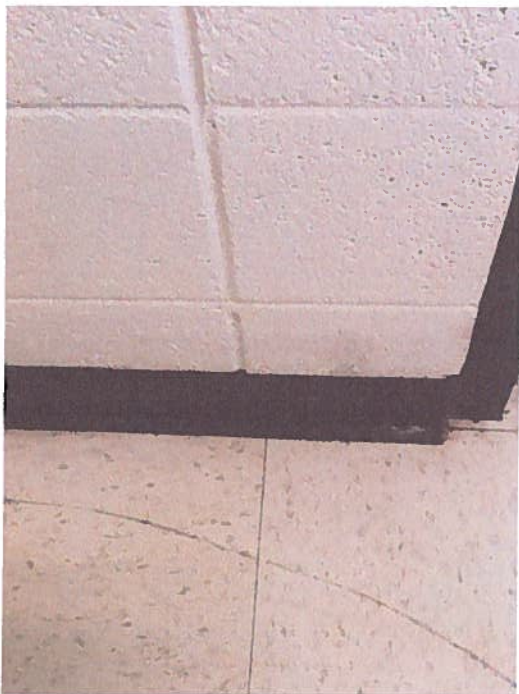
Total number of samples collected	3
Total number of samples analyzed	3
IS ASBESTOS-CONTAINING MATERIAL PRESENT?	NO
Samples Collected by	EMET
Sample Numbers	302-46-3h1, 302-46-3h2, 302-46-3h3
Samples Analyzed by	EMET
Number of Sallent Designations

Sample Area # 302-46-3H
4" brown covebase

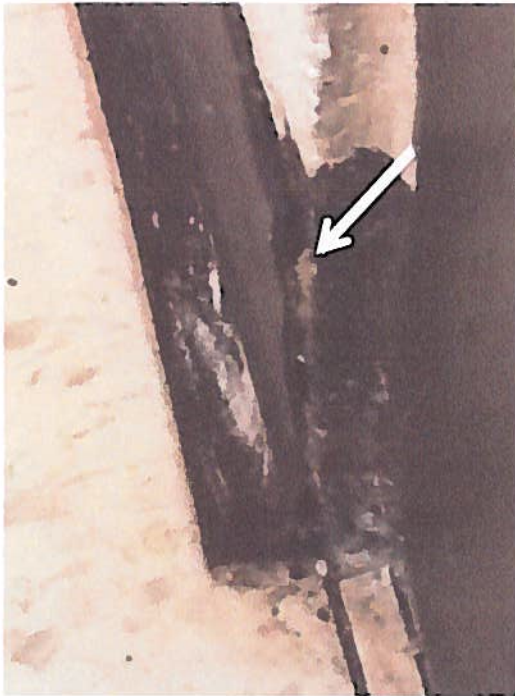
Sample Area # 302-46-3I
beige adhesive (beneath 4"
brown covebase)

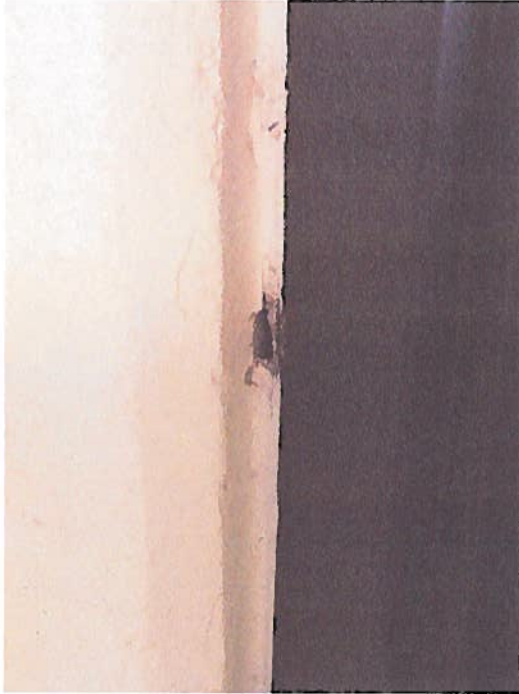
Sample Area # 302-46-3K
white caulking at door
frame

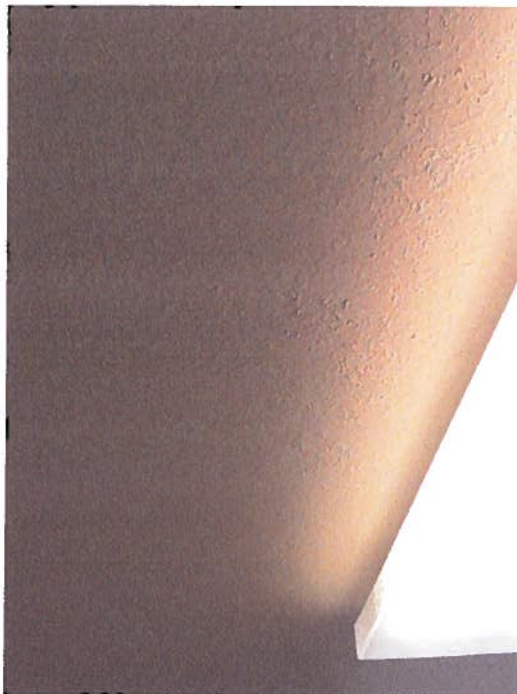
Sample Area # 302-46-3L
white skimcoat

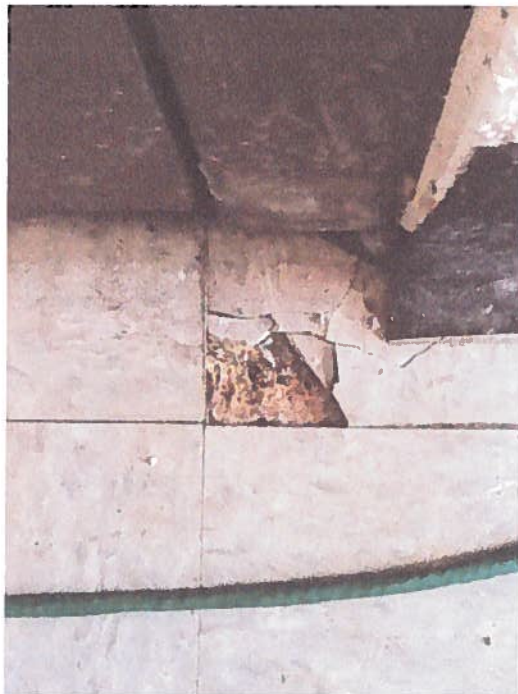
Sample Area # 302-46-3N
beige adhesive (beneath
12"x12" light-gray w/dark-
gray streaks VFT)

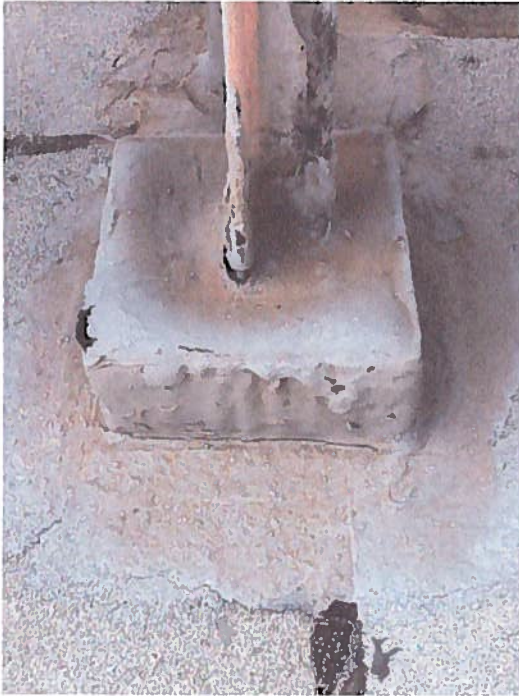
Sample Area # 302-46-RA
gray patch/sealant

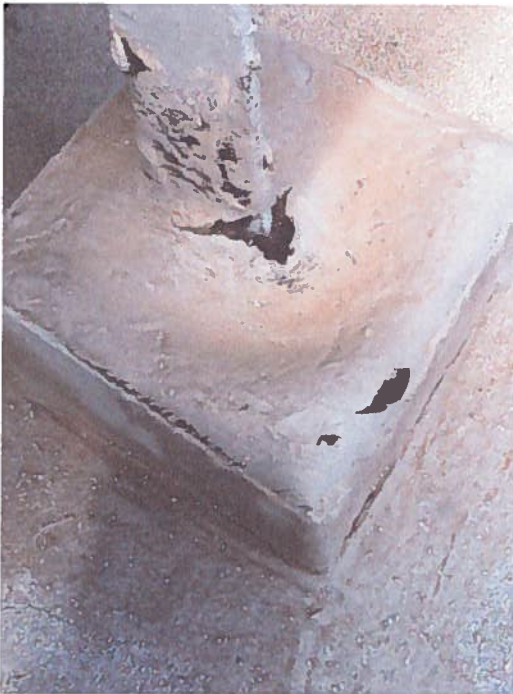
Sample Area # 302-46-RB
silver roof coating
