November 1, 2016

Report of: Kevin K. Eckert
ISA Board Certified Master Arborist WE-1785BU

Project: Tree Risk Assessment and Risk Reduction Recommendations
Job No. CA-1601

Project Site: Hawaii State Veterans Cemetery
45-349 Kamehameha Highway Kaneohe

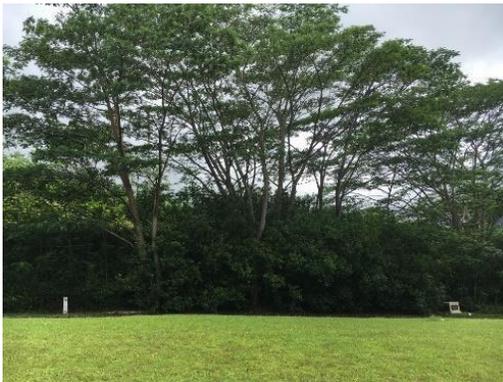
Albizia trees are recognized to possess a natural, structural defect whereby they may shed large branches at unexpected intervals or fall over in whole during strong winds. This structural defect is caused by their exceptionally tall growth habit with long branches and foliage typically loaded at the end of these branches. This conditions produces an exceptional lever arm load that can exceed the carrying capacity of this relatively weak structured wood and sometimes inadequate structural root systems.

Albizia trees are recommended to be felled (F) whenever practical or crown reduced pruned (CR) if felling is not practical. This invasive species should be removed or managed whenever practical when it is in a location where it is capable of striking and significantly injuring persons or damaging property because of its common failure characteristics, exceptionally large size, exceptionally fast growth rate, and location on sites with relatively challenging access for management. However, felling and disposal of the great amount of debris generated from large trees can be prohibitively expensive in some instances. In these instances, other, less expensive alternatives may be applied. These alternatives may only reduce risk in the short-term, but they may permit better cost distribution within limited budgets.

Crown reduction pruning that correctly removes approximately 20% to 25% of the top and/or ends of target branches will reduce the structural load on the whole tree or target branch and reduce the likelihood of tree or tree part failure. Where practical, shortening tree tops or long branches may also result in a reduced tree height and/or branch length such that a tree part is less likely to strike the subject target. However, additional pruning must be conducted in the future to manage continuing tree growth.

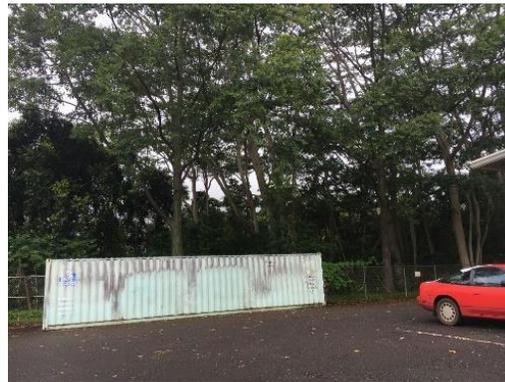
Rainbow Eucalyptus

Rainbow eucalyptus trees are recognized to possess generally weaker structural integrity and branches may fail in strong winds. The rainbow eucalyptus near to the Maintenance Shop generally are protected from strong winds by nearby large trees and therefore their likelihood of failure is reduced.

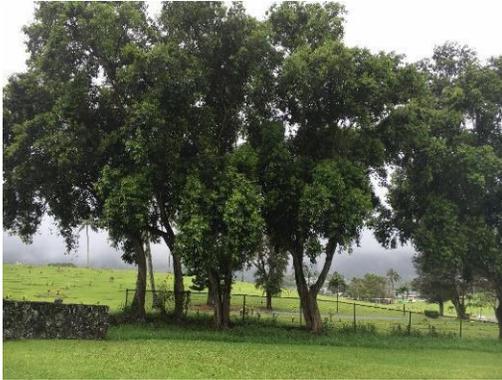
Java Plum

Java plum can grow over 80 feet tall with trunk diameters over 24 inches. It is a common, non-native and widespread, invasive tree throughout wet low-lands of Hawaii. It is native to southern Asia and has been cultivated in Hawaii since 1871. It possesses a brittle branch structure that readily breaks in strong winds.

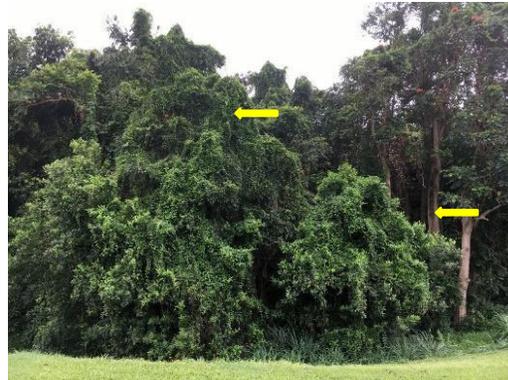
African Tulip

Some of the African tulip trees (28, 29, 30 and 31) were covered in vines and in declining health due to competition from the vines. A few albizia trees in the southeast corner of the property showed signs of significant decline and deadwood. Tree 178 were observed to be dead.

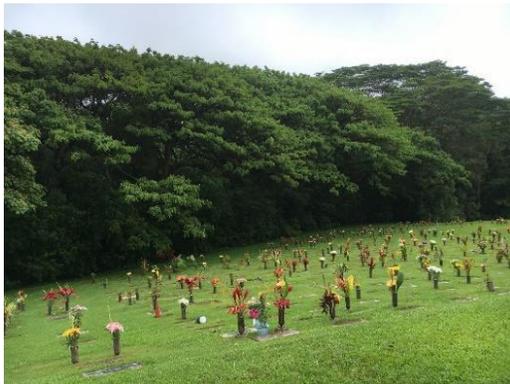
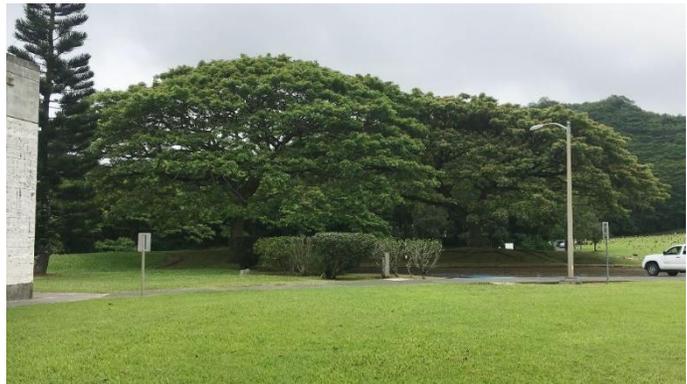
Monkeypod Trees

Monkeypod trees 74, 75 and 76 possessed moderate amounts of large deadwood. Formation of deadwood in monkeypod trees is a natural progression and should be managed on a cycle based on the formation of this deadwood, usually approximately every 24 months.
