Demolition of Building 301

Fort Ruger, Hawaii

PN 15140035, Job No. CA-1418-C

Specifications

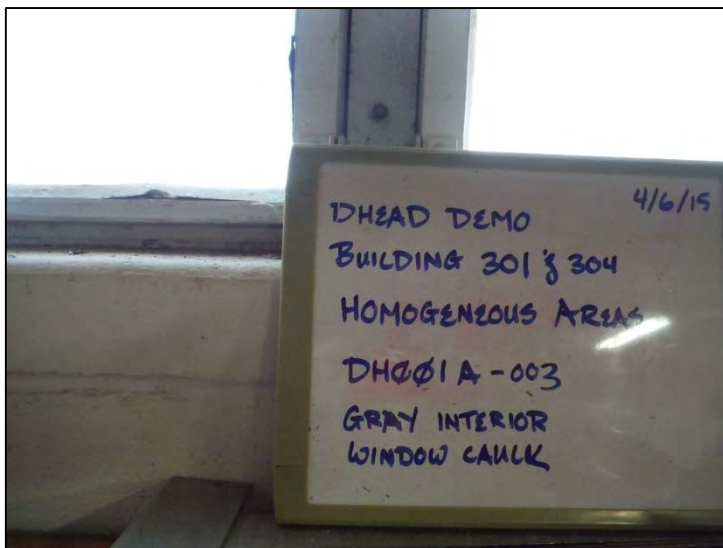
Photograph 10.

The gray interior window caulking found on the window pane perimeters in the CERFP Building 301, Rooms 1, 2, 3, and 15 were found to contain 2% asbestos.

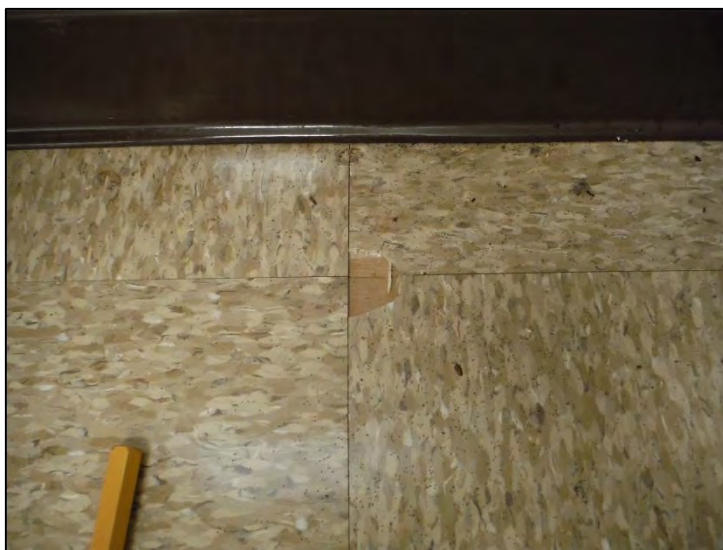
Photograph 11.

The brown vinyl floor tile and associated mastic found beneath the mottled brown 12"x12" VFT in the CERFP Building 301, Room 11, was found to contain 2-3% asbestos.

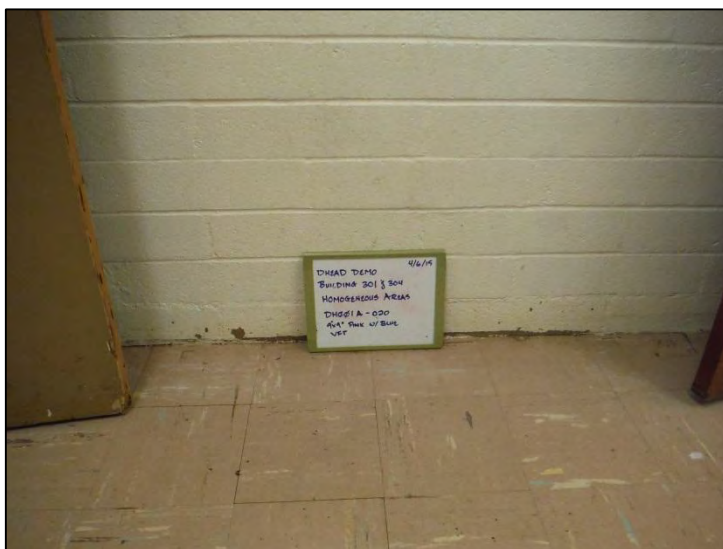
Photograph 12.

The pink and blue 9"x9" vinyl floor tile found in the CERFP Building 301, Rooms 7, 8, 9, 10, and 13 were found to contain asbestos. The black mastic beneath this tile was found to not contain asbestos.

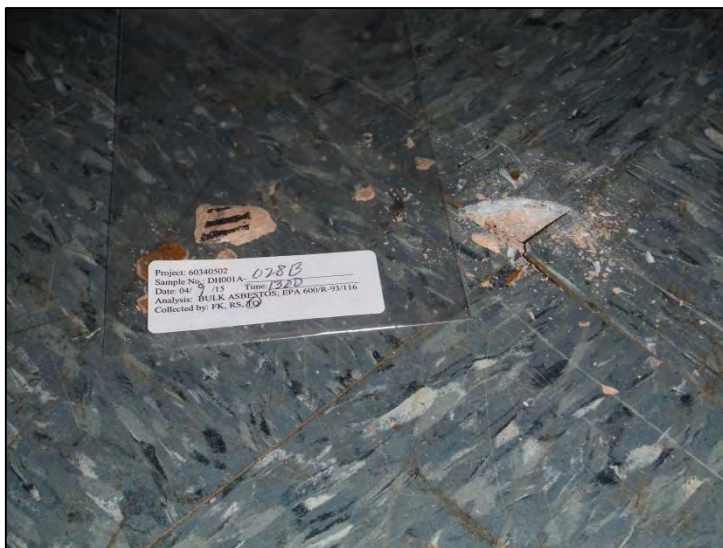
Photograph 13.

The beige VFT found beneath the blue 12"x12" VFT in the CERFP Building 301 Room 14 was found to contain 4-5% asbestos. No asbestos was detected in the black mastic beneath.

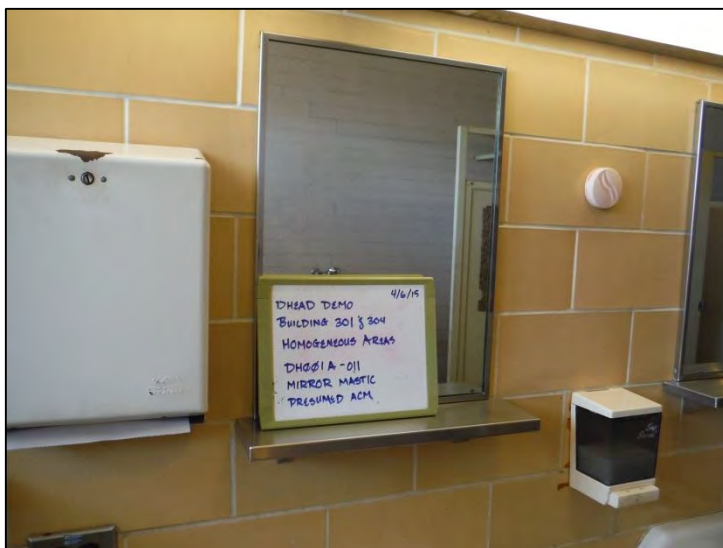
Photograph 14.

Mastic, suspected to be behind the mirrors in both restrooms of the CERFP Building 301 are presumed to contain asbestos.

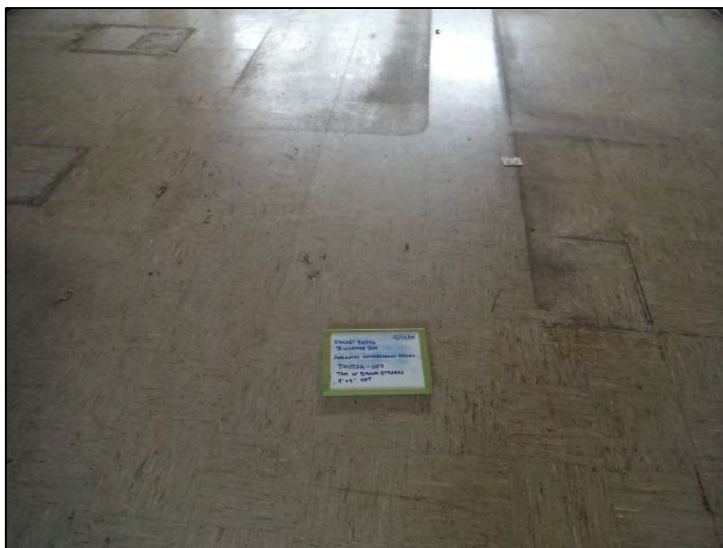
Photograph 16.

The black asphaltic mastic found beneath the tan and brown 9"x9" VFT in the CSMS-1 Building 304 complex was found to contain 3% asbestos. The tan and brown VFT did not contain asbestos.

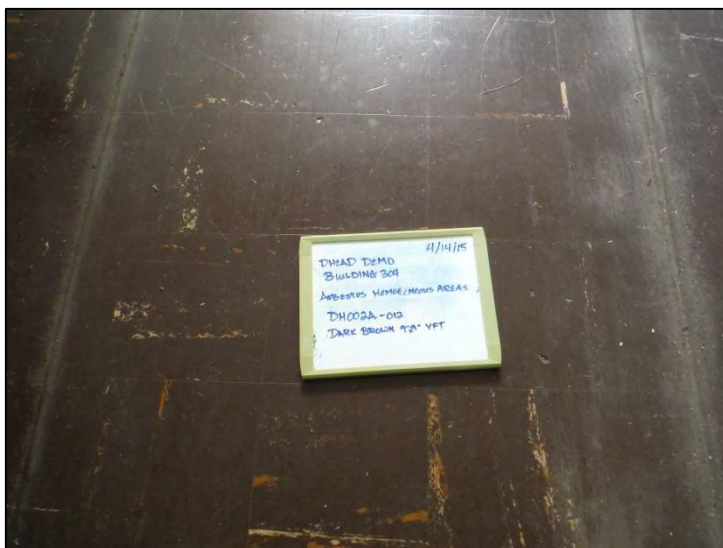
Photograph 17.

The dark brown 9"x9" and associated black asphaltic mastic beneath, found in Rooms 4, 6, and 7 of the CSMS-1 Building 304 complex were found to contain 2% asbestos.

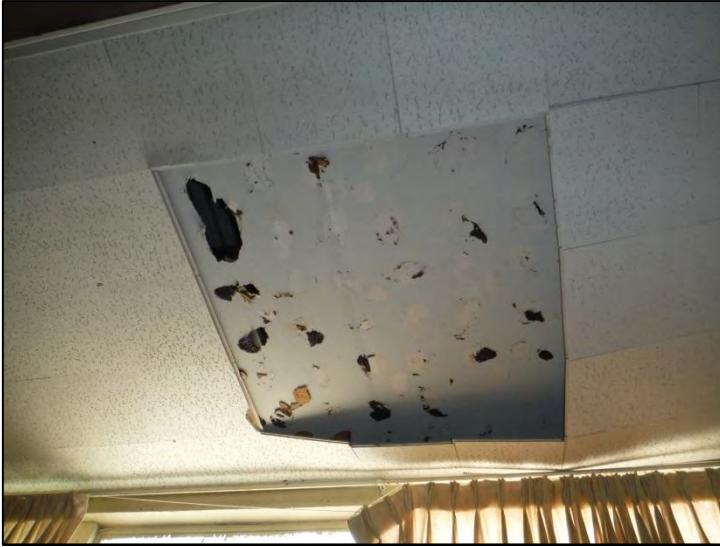
Photograph 19.

The acoustic ceiling tile backer board found in Rooms 4, 5, 6, 7, 9, 13, and 20 in the CSMS-1 Building 304 complex were found to contain 25% asbestos. The acoustic ceiling tiles and associated mastic did not contain asbestos.

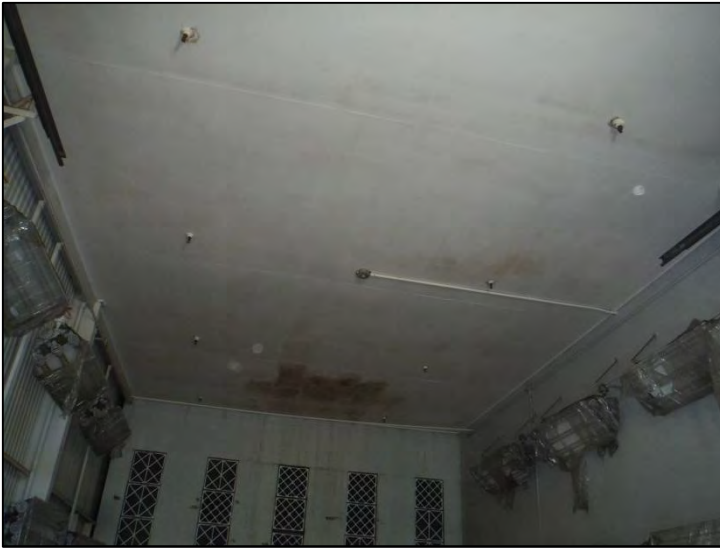
Photograph 20.

A view of the asbestos containing backer board in Room 20 (south paint booth) of the CSMS-1 Building 304 complex. This board was not present in Room 19 (north paint booth).

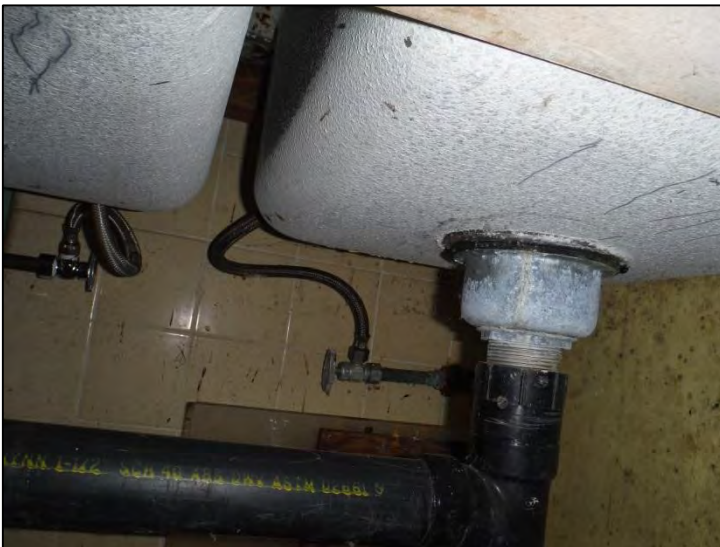
Photograph 21.

The sink insulation found beneath the kitchen sink in Room 11 of the CSMS-1 Building 304 complex was found to contain 3% asbestos.

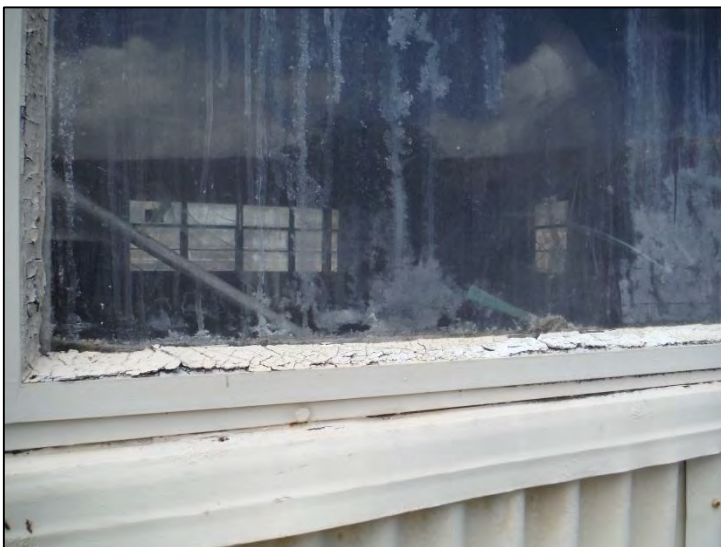
Photograph 24.

The tan and gray caulking found around the exterior window panes of the Carpenter Shop of the CSMS-1 Building 304 complex was found to contain 2% asbestos.

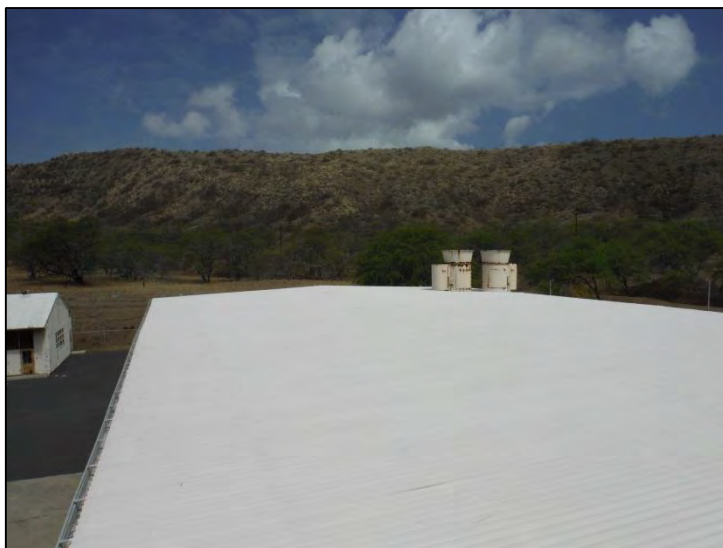
Photograph 25.

A silver paint is present on the metal roof substrate beneath the white polymer roof coating of the CSMS-1 Building 304 complex. This paint was found to contain 2% asbestos.

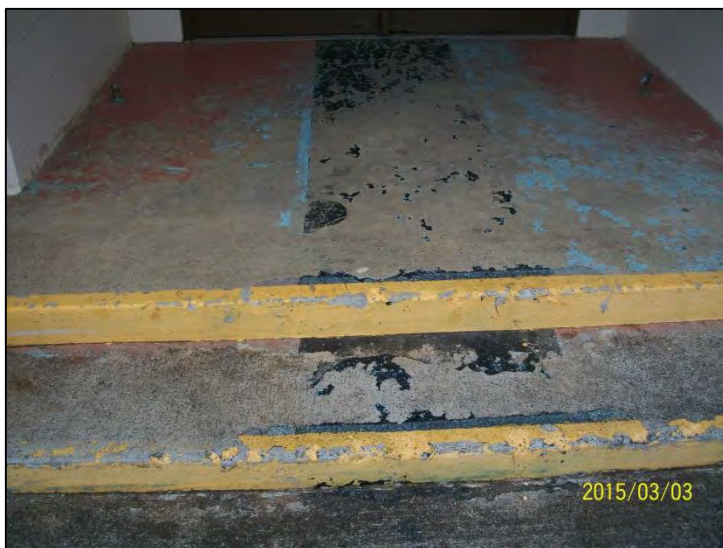
Photograph 29.

The yellow paint on concrete found on all concrete entry stairs and the red and blue paint found on the north stairs to the CERFP Building 301 were found to be LBP.

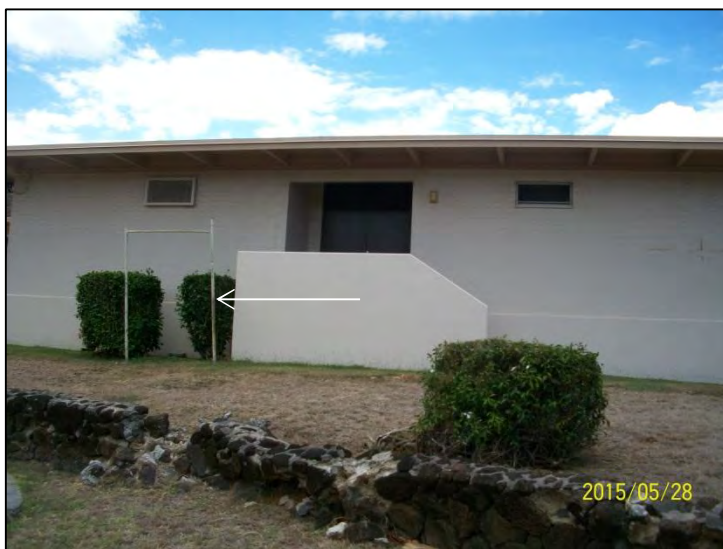
Photograph 30.

The faded yellow paint over orange paint on the metal posts, indicated by the arrow, on the south side of the CERFP Building 301 was found to be LBP.

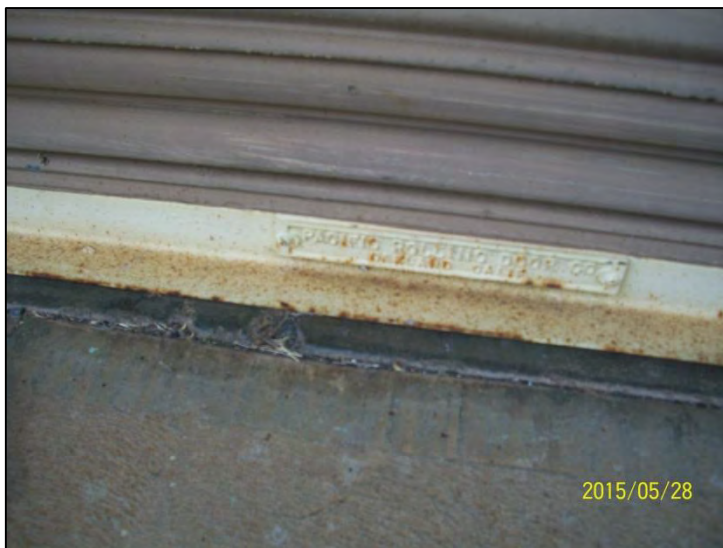
Photograph 31.

The yellow paint on the bases of the rollup doors in Rooms 1, 2, 12, 14, 16, and 17 of the CSMS-1 Building 304 complex was found to contain LBP.

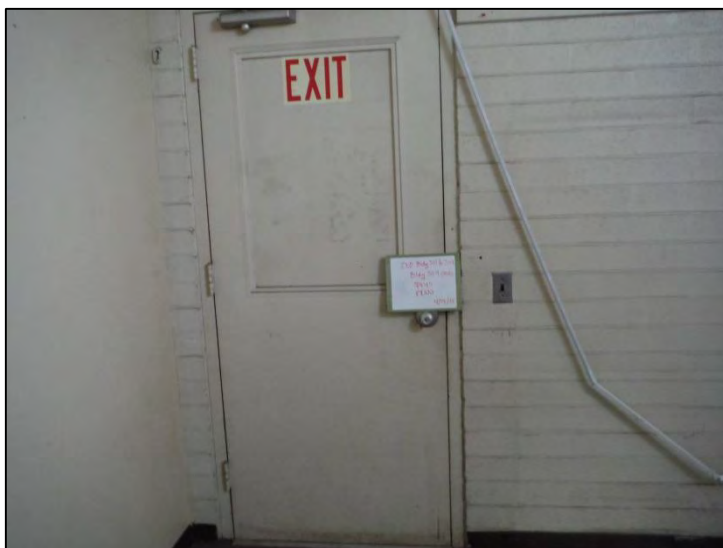
Photograph 32.

The beige/off-white paint on the interior side of metal doors in Room 3 and Room 7 of the CSMS-1 Building 304 complex was found to be LBP.

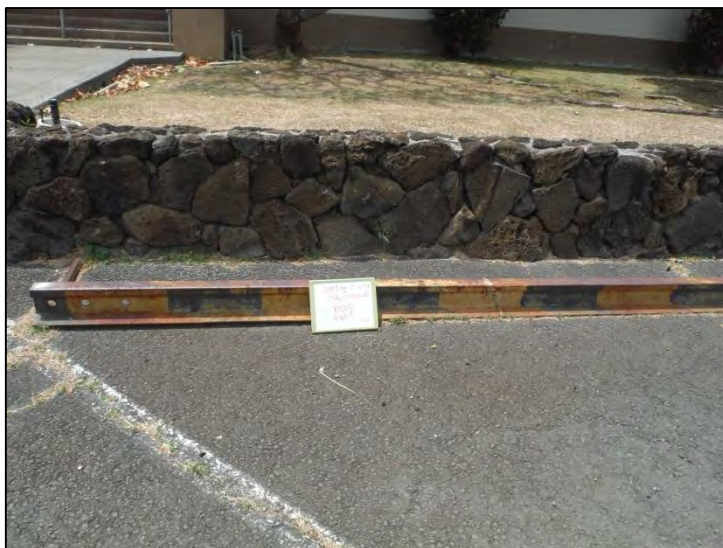
Photograph 34.

The yellow and black paint found on the railroad rails in the parking lot of the CSMS-1 Building 304 complex was found to be LBP.

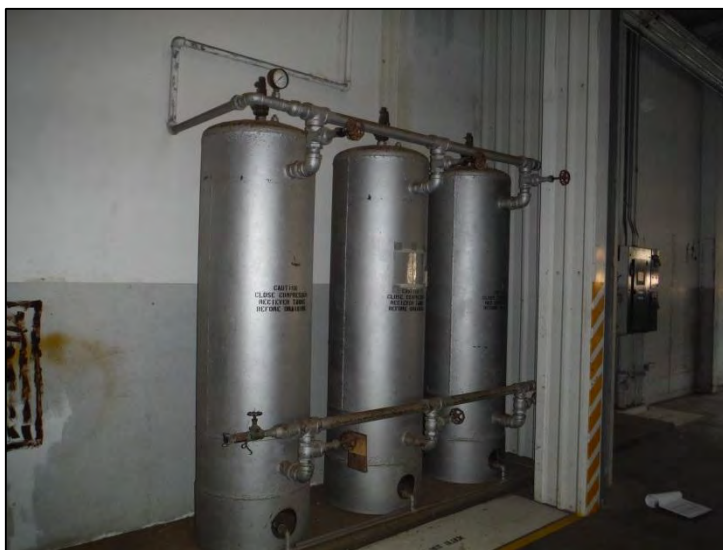
Photograph 35.

The silver paint found on the compressors and associated piping in Room 18 of the CSMS-1 Building 304 complex was found to be LBP.

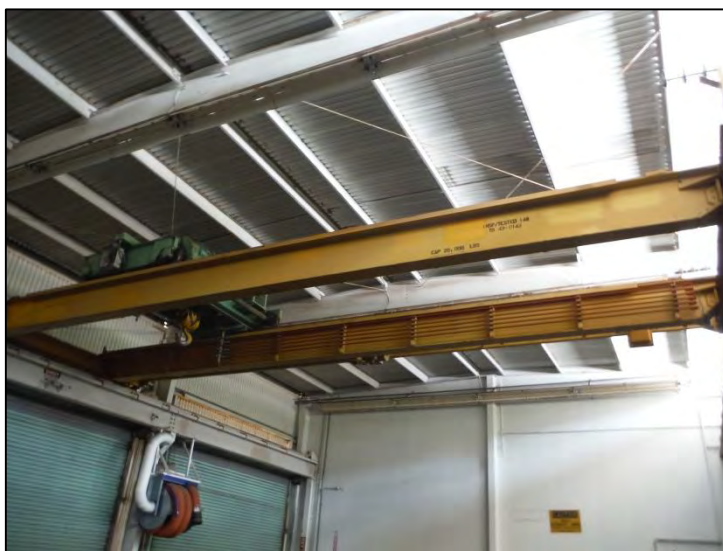
Photograph 36.

The yellow paint found on the overhead crane in Room 18 of the CSMS-1 Building 304 complex was found to be LBP.

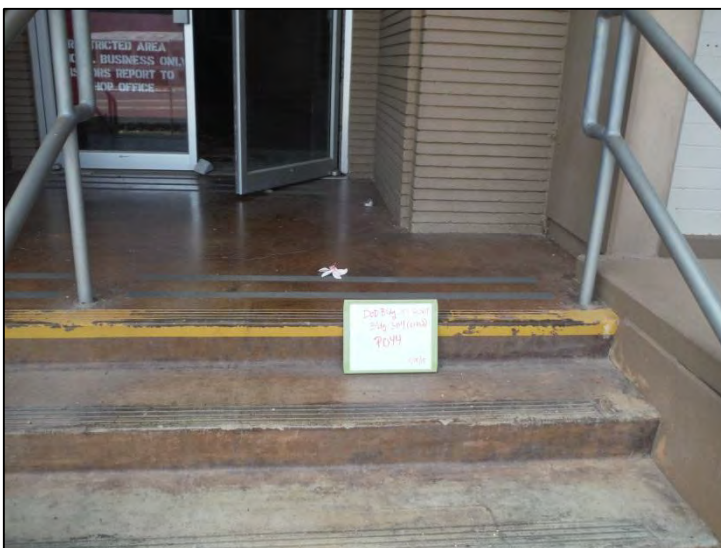
Photograph 38.

The yellow paint found on the concrete southeast stairs of the CSMS-1 Building 304 complex was found to be LBP.

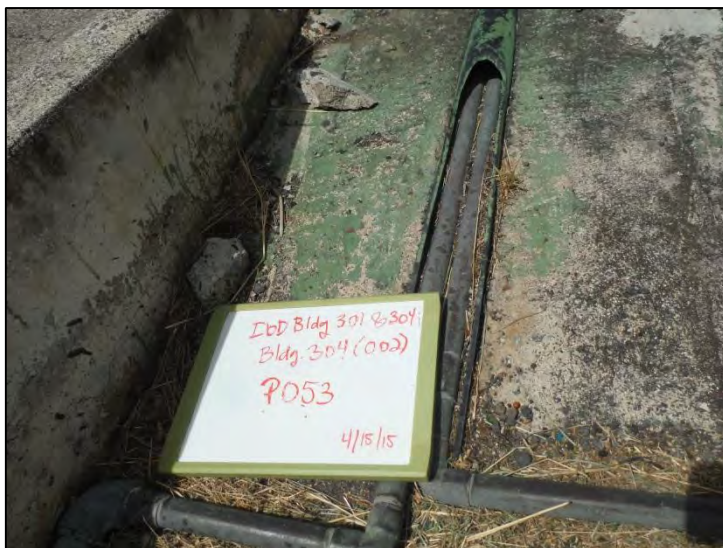
Photograph 40.

The green paint on concrete found on the base of the grease rack (Building 304B) at the CSMS-1 Building 304 complex was found to be LBP.

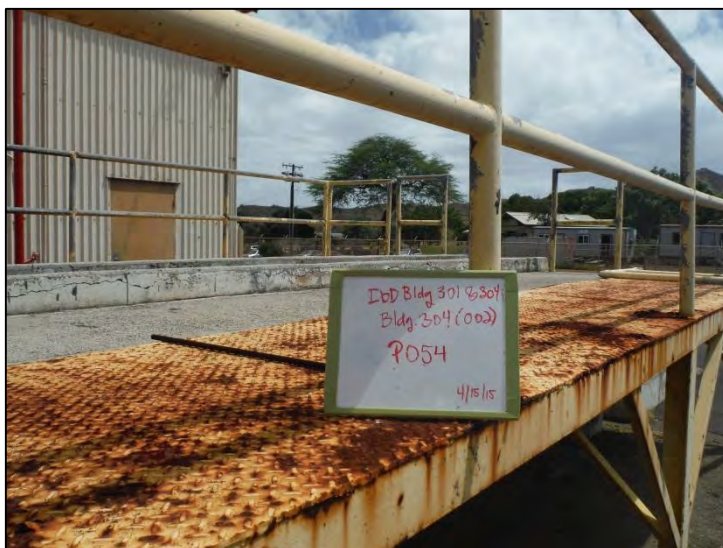
Photograph 41.

The yellow paint found on the rails of the grease rack at the CSMS-1 Building 304 complex was found to be LBP.

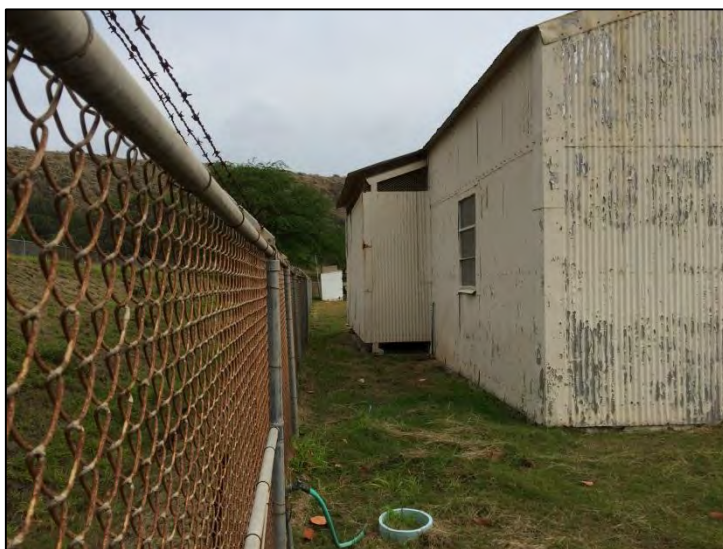
Photograph 42.

The flaking sand colored paint on the exterior of the Carpenter Shop (Building 304D) at the CSMS-1 Building 304 complex was found to be LBP.

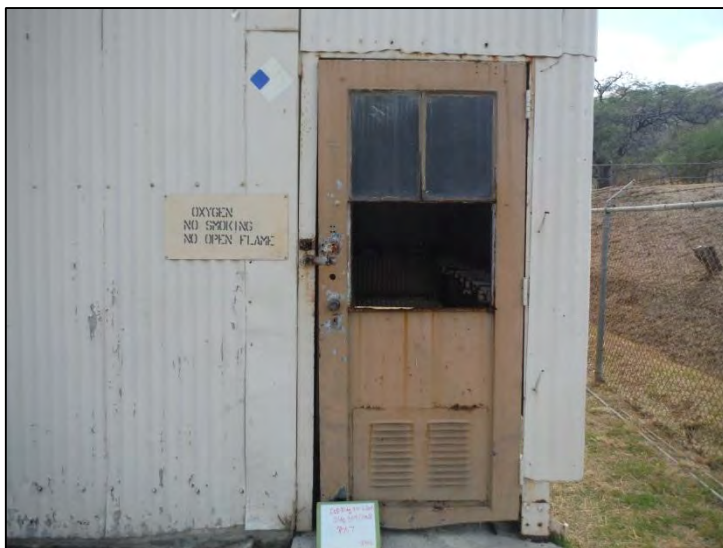
Photograph 43.

The brown paint on the exterior of the Carpenter Shop (Building 304D) door at the CSMS-1 Building 304 complex was found to be LBP.

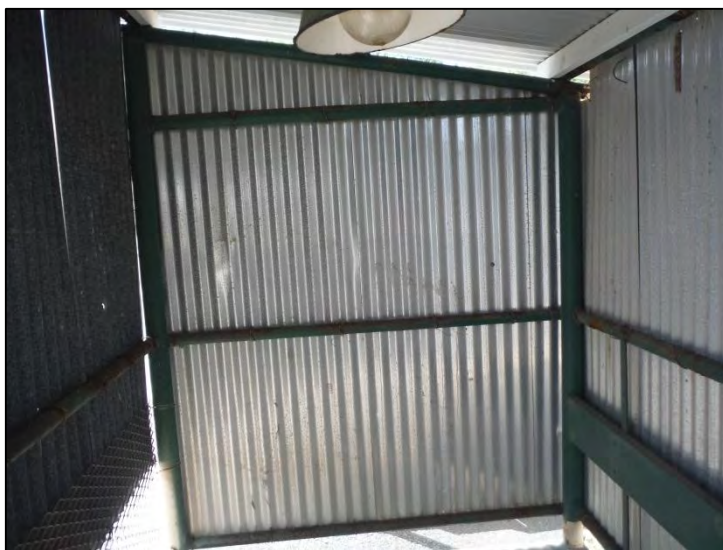
Photograph 44.

The green paint on metal and wood found in the Battery Shop at the CSMS-1 Building 304 complex was found to be LBP.

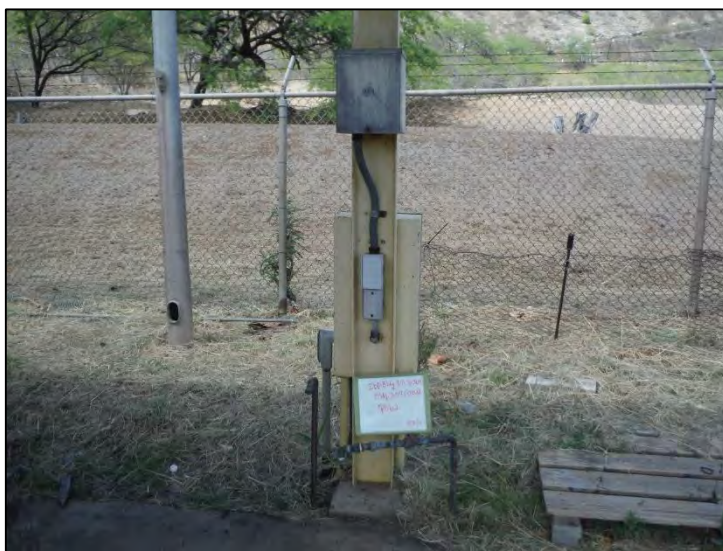
Photograph 45.

The yellow paint on the metal post in the Battery Shop at the CSMS-1 Building 304 complex was found to be LBP.

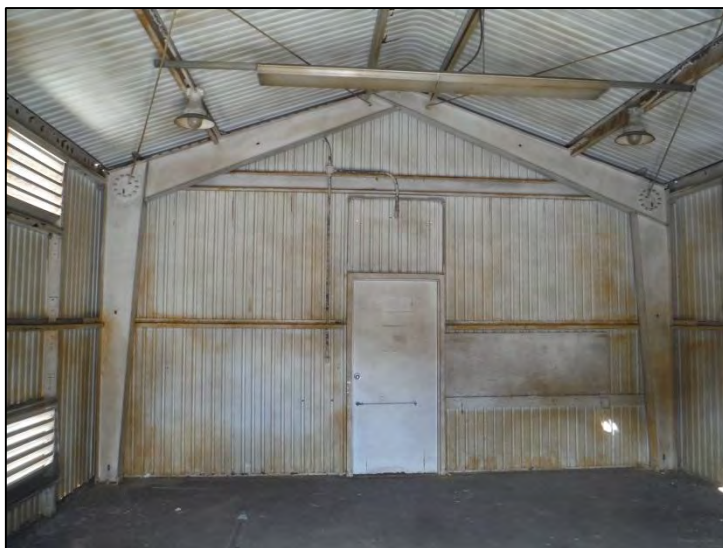
Photograph 46.

The off-white paint found on the interior of the Canvas Repair Shop (Building 304A) at the CSMS-1 Building 304 complex was found to be LBP.

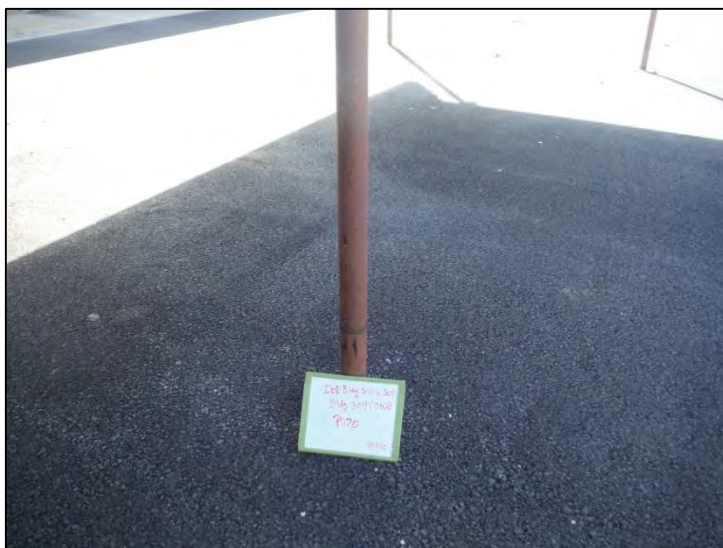
Photograph 47.

The dark brown paint found on the support poles of the lunch and vehicle shelters (Buildings 304F and 304G) at the CSMS-1 Building 304 complex was found to be LBP.

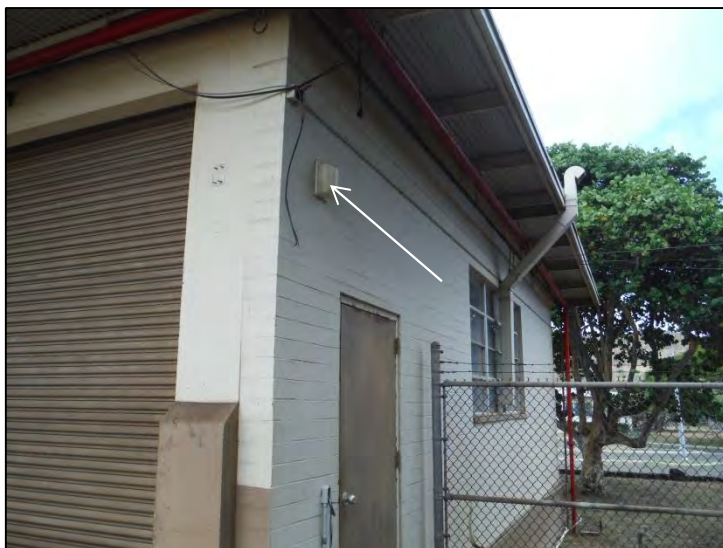
Photograph 49.

During the survey, six sodium bulbs were observed in the CERFP Building 301, and nine sodium bulbs were observed throughout the CSMS-1 Building 304 complex (indicated by arrow). These bulbs potentially contain mercury. Their fixtures house potentially PCB-containing ballasts.

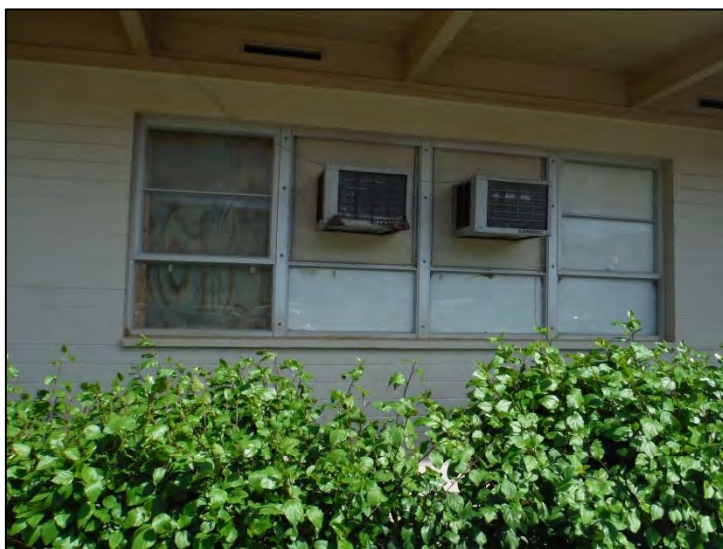
Photograph 51.

During the survey, 14 in-window air conditioners (ACs) were observed in the CERFP Building 301, and 7 in-window ACs were observed throughout the CSMS-1 Building 304 complex. These ACs potentially contain ozone depleting substances (ODSs).

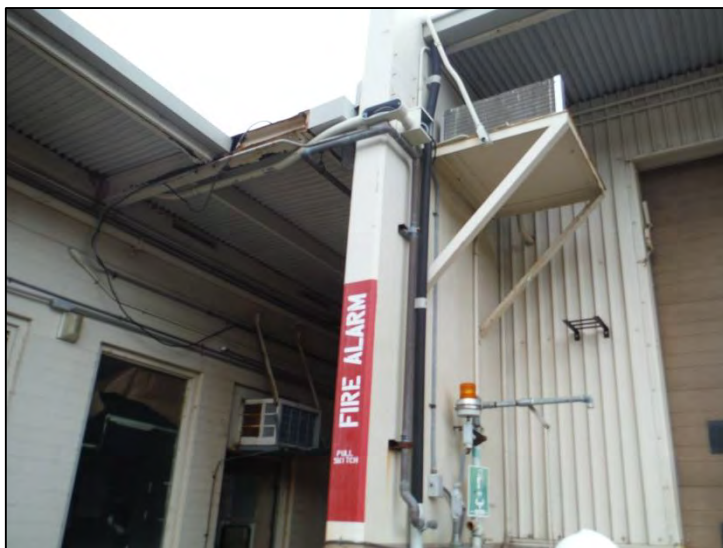
Photograph 52.

A condenser for the AC unit in the vault within Room 5 of the CSMS-1 Building 304 building was located on the north side of the building. This condenser may contain ODSs.
