# Demolition of Building 304 Complex

Fort Ruger, Hawaii

PN 15140035, Job No. CA-1418-C

## *Specifications*

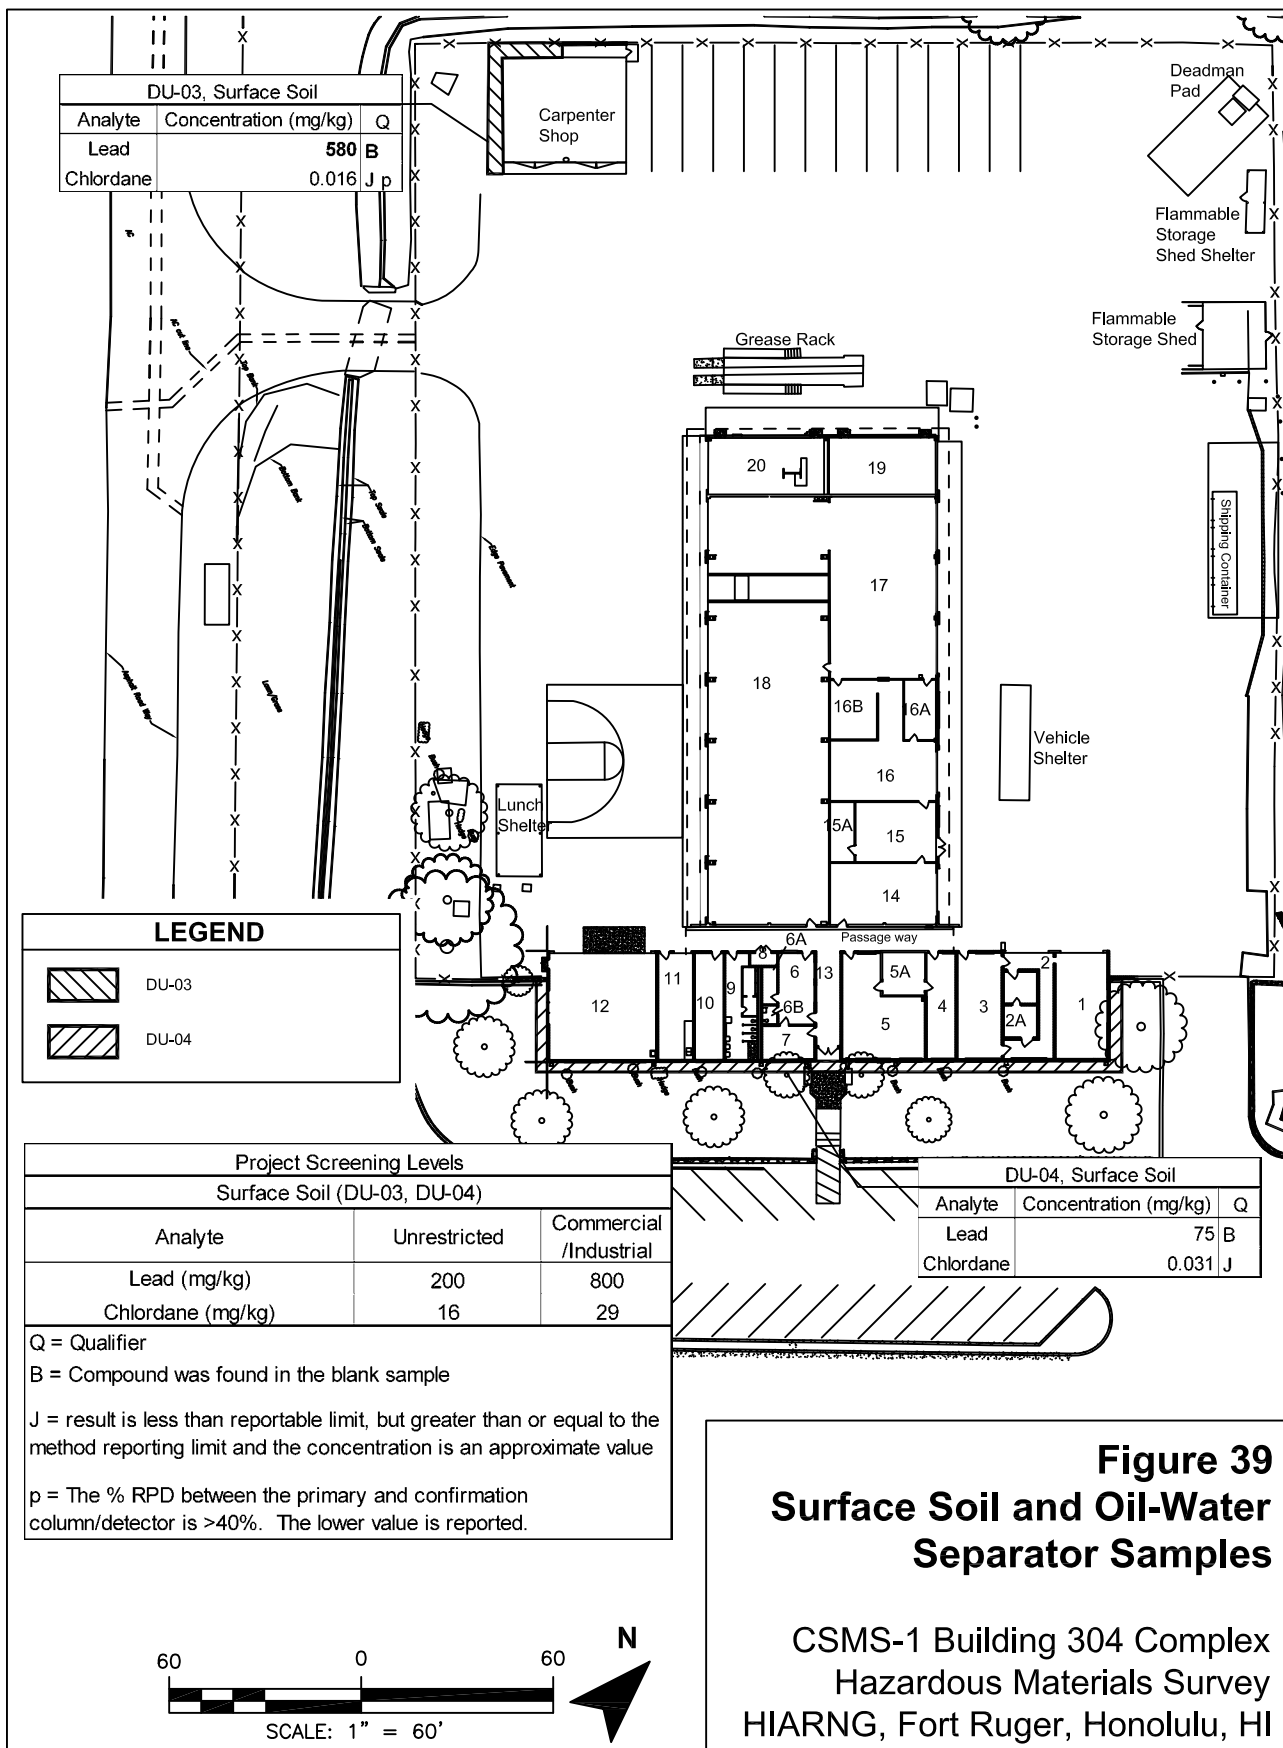
DU-03, Surface Soil		
Analyte	Concentration (mg/kg)	Q
Lead	580	B
Chlordane	0.016	J p

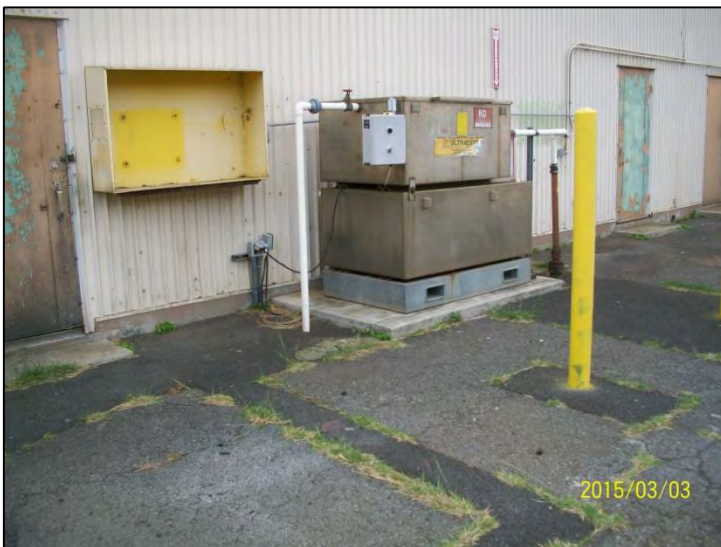
Photograph 6.

A view of the oil-water separator unit and waste oil holding tank on the northwest end of the CSMS-1 Building 304.

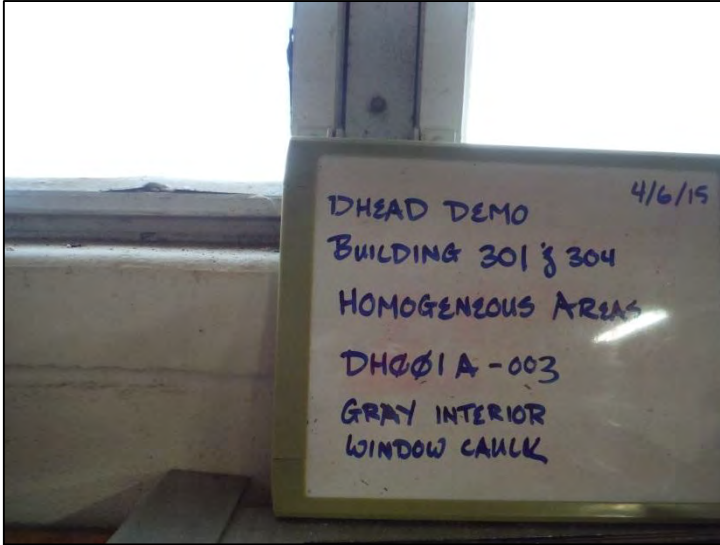
Photograph 10.

The gray interior window caulking found on the window pane perimeters in the CERFP Building 301, Rooms 1, 2, 3, and 15 were found to contain 2% asbestos.

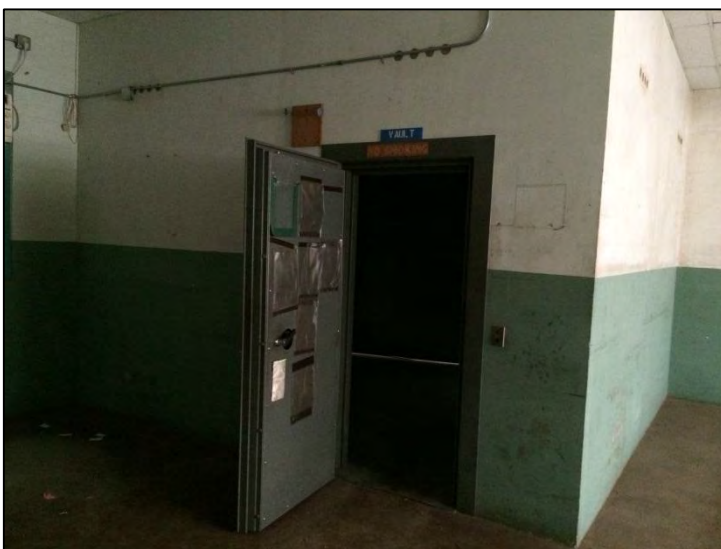
Photograph 27.

One vault door located in the CERFP Building 301, and two vault doors located in the CSMS-1 Building 304 are assumed to contain asbestos.

- Door insulation, assumed to be within the vault doors at both the CERFP Building 301 (one door) and the CSMS-1 Building 304 (two doors), shall be assumed to contain asbestos (Photograph 27). Each of the doors is approximately 22 ft<sup>2</sup> in size.

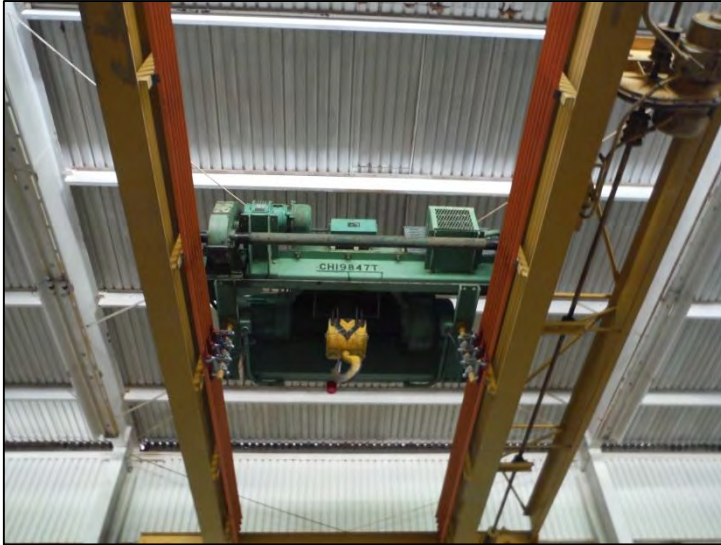
Photograph 37.

The sea green paint found on the overhead crane in Room 18 of the CSMS-1 Building 304 complex was found to be LBP.

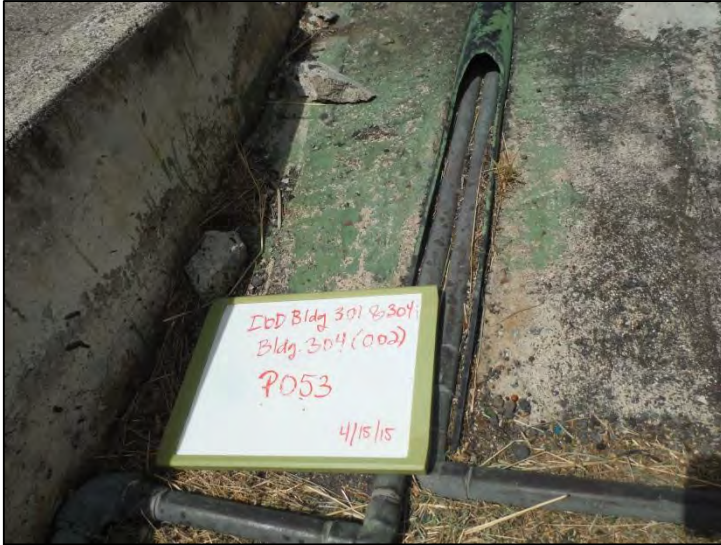
Photograph 40.

The green paint on concrete found on the base of the grease rack (Building 304B) at the CSMS-1 Building 304 complex was found to be LBP.

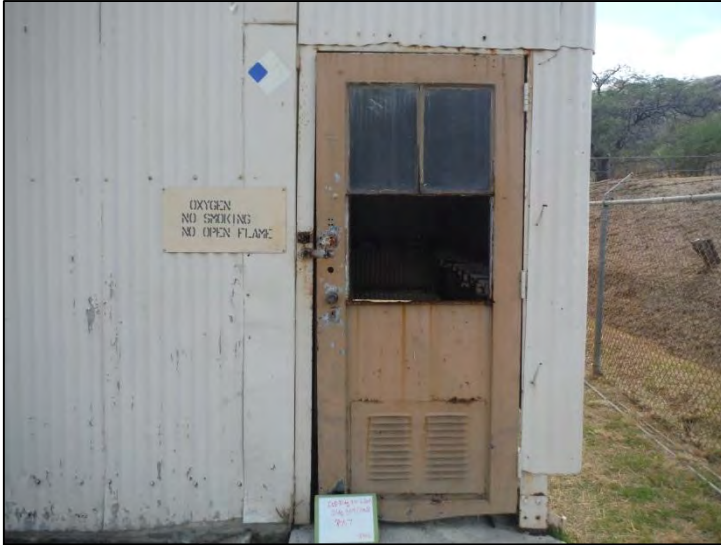
Photograph 43.

The brown paint on the exterior of the Carpenter Shop (Building 304D) door at the CSMS-1 Building 304 complex was found to be LBP.

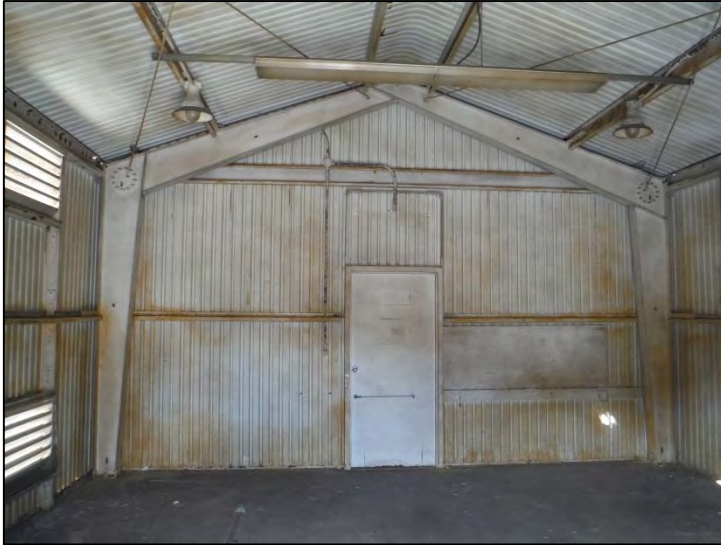
Photograph 46.

The off-white paint found on the interior of the Canvas Repair Shop (Building 304A) at the CSMS-1 Building 304 complex was found to be LBP.

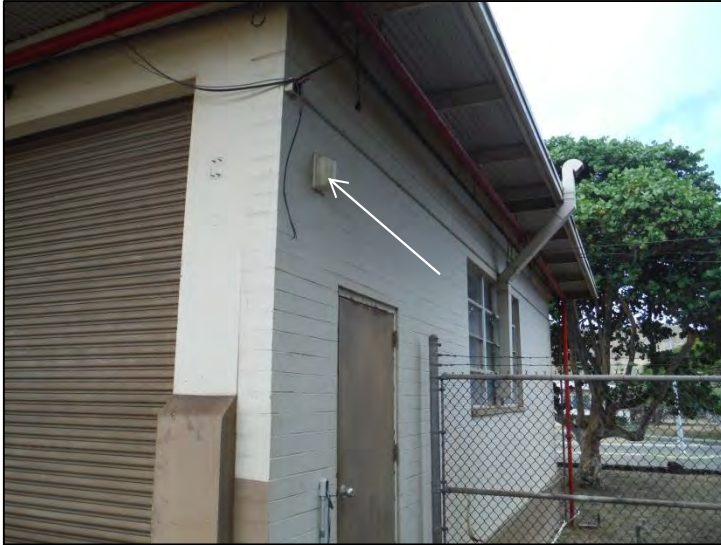
Photograph 49.

During the survey, six sodium bulbs were observed in the CERFP Building 301, and nine sodium bulbs were observed throughout the CSMS-1 Building 304 complex (indicated by arrow). These bulbs potentially contain mercury. Their fixtures house potentially PCB-containing ballasts.

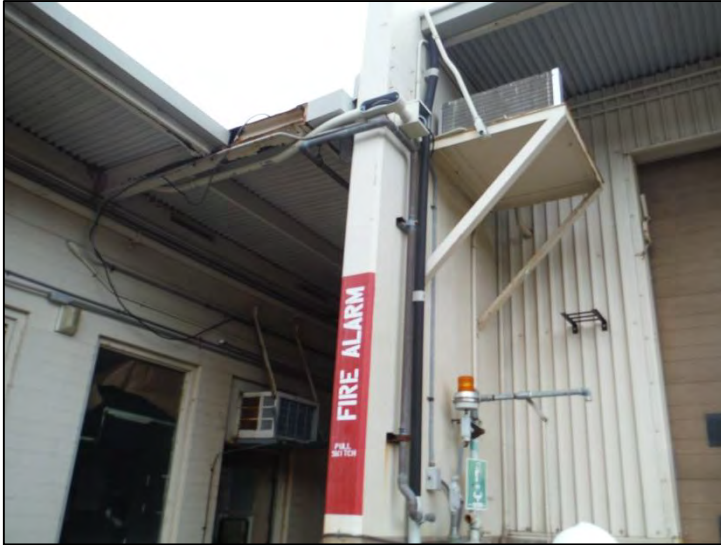
Photograph 52.

A condenser for the AC unit in the vault within Room 5 of the CSMS-1 Building 304 building was located on the north side of the building. This condenser may contain ODSs.

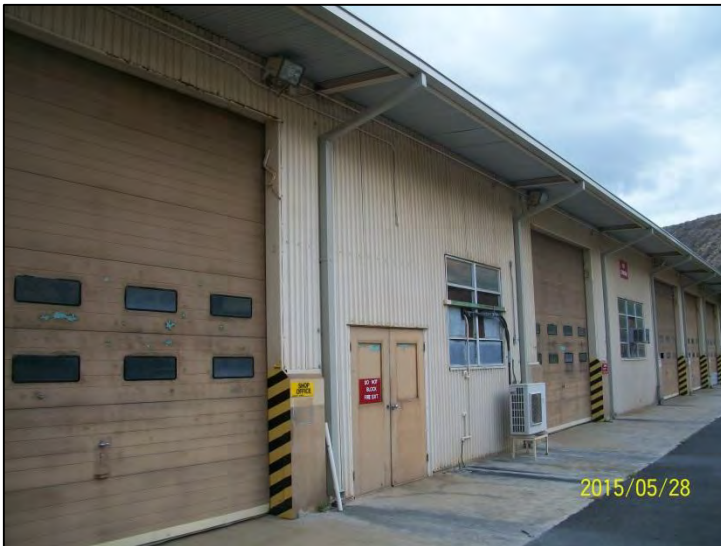
Photograph 53.

A condenser for the AC unit in Room 15 of the CSMS-1 Building 304 building was located on the north side of the building. This condenser may contain ODSs.

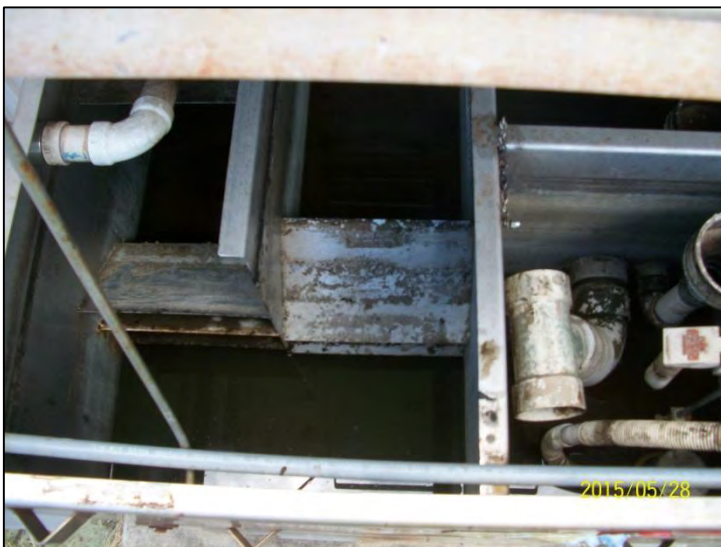
Photograph 54.

The interior of the oil-water interceptor unit at the CSMS-1 Building 304 complex. It contained approximately 6 inches of water.
