Sample Log and Notes

46	Kalaeloa Building 46
----	----------------------

LABORATORY REPORT

Client: Riecke Sunnland Kono Architects, Ltd. Building: Kalaeloa Building 46
Address: P.O. Box 1627 Kahului, HI 96732-1627 Enterprise Avenue Kalaeloa, HI
NVLAP LAB CODE 101807-0
Approved Signatory:

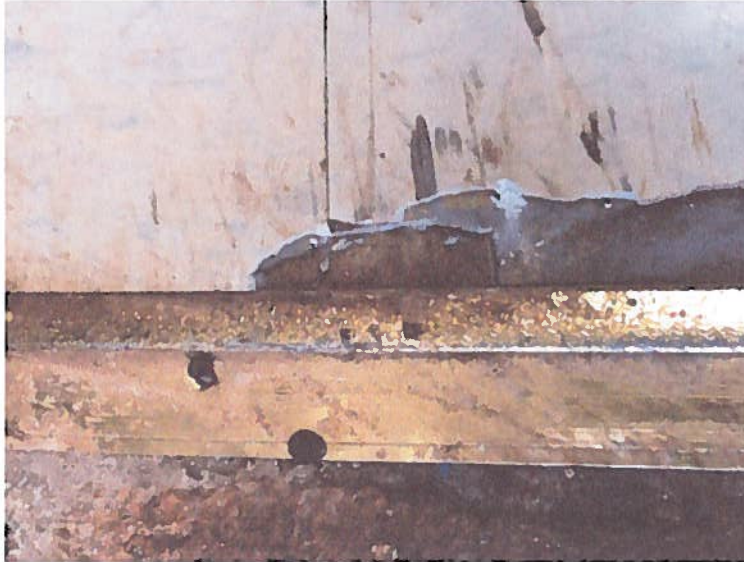
Sample Area # 302-46-1S

beige adhesive (beneath 12" X 12" cream w/ blue specks
VFT/beige adhesive/blue VFT)

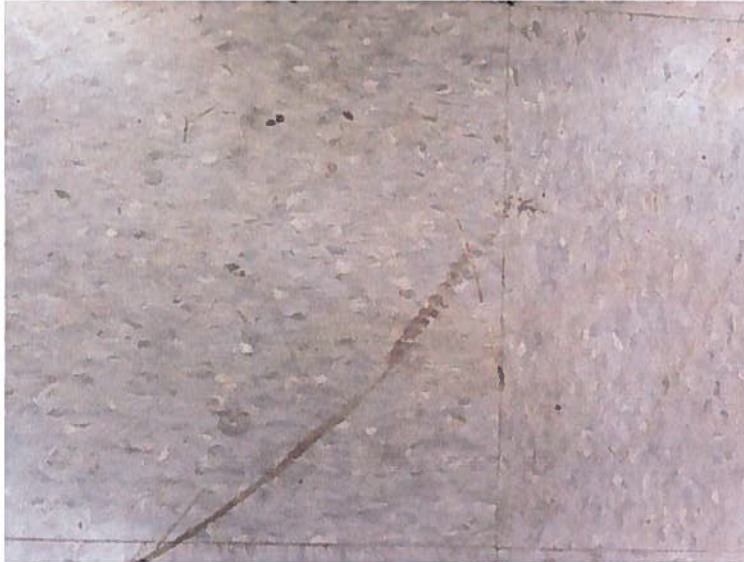
Sample Area # 302-46-2E

12" X 12" light-gray w/dark-gray streaks VFT

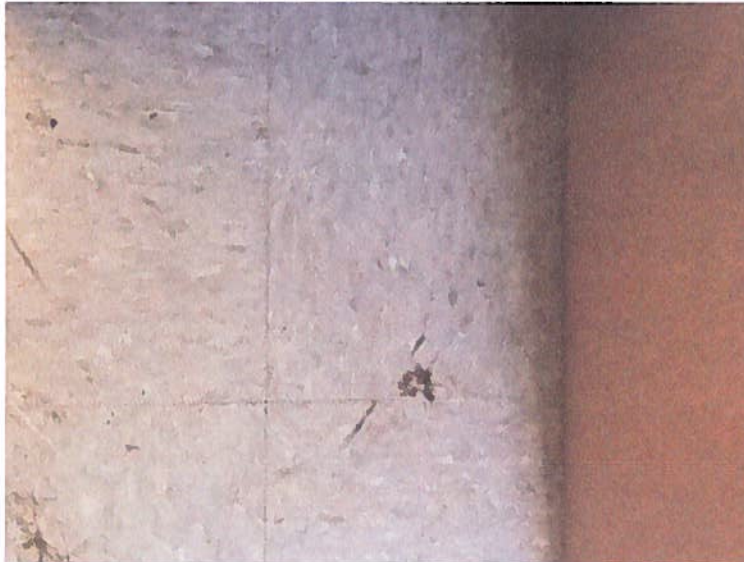
Sample Area # 302-46-3M

12"x12" light-gray w/dark-gray streaks VFT
